Access Compliance Report

Public Rights-of-Way

(Curb Ramps)

Intersection ID: 12508	Main Street: BELVEDERE_AV	Cross Street: CLUB_RD	Location: E
ADA ID: DE52B0623898	Ramp Type: Perp	Initial Pass/Fail: Fail	Overall Compliance: No
Severity Score: 22.5			
Codes/Mitigation Info/Possible Solution		Field Measurements/Component Compliance

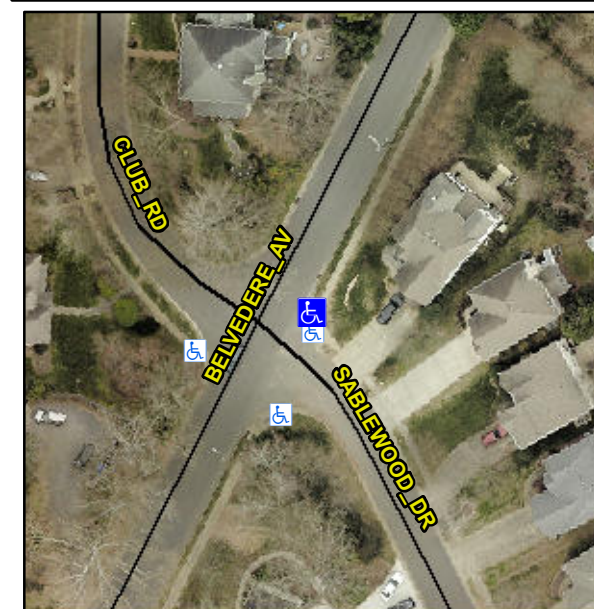
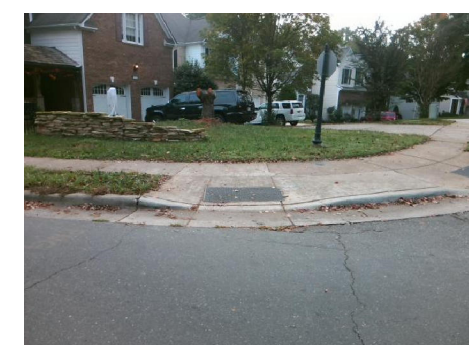
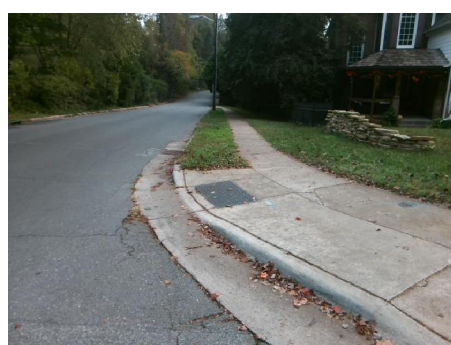
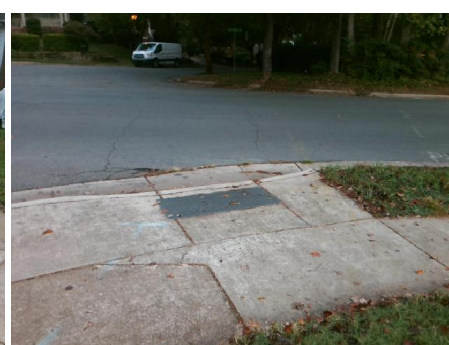
Not Found, R304.5.1, R304.2.2, R304.5.3

Compliance	Description	Data	Compliance	Description	Data
N/A	Ramp Length (in)	54.5	No	Ramp Slope (%)	9.5
No	Ramp Width (in)	42.0	No	Ramp XSlope (%)	3.4
N/A	Flare Type LT	N/A	N/A	Flare Type RT	N/A
N/A	Flare Slope LT (%)	N/A	N/A	Flare Slope RT (%)	N/A
N/A	Flare Traversable LT?	N/A	N/A	Flare Traversable RT?	N/A
N/A	Landing Length (in)	N/A	N/A	DWS Provided?	N/A
N/A	Landing Width (in)	N/A	N/A	DWS Contrast?	N/A
N/A	Landing Slope (%)	N/A	N/A	DWS Length (in)	N/A
N/A	Landing X Slope (%)	N/A	N/A	DWS Full Width?	N/A
N/A	Landing Curb? (Y/N)	N/A	N/A	DWS Offset (in)	N/A
N/A	Shared Landing?	N/A			
N/A	Gutter Ponding?	N/A	N/A	Gutter Slope (%)	N/A
N/A	Gutter Lip Ht (in)	N/A	N/A	Gutter X Slope (%)	N/A
N/A	Painted X Walk1?	No	N/A	Painted X Walk2?	N/A
	X Walk 1 Direction	To W		X Walk 2 Direction	N/A
N/A	X Walk 1 Width (in)	N/A	N/A	X Walk 2 Width (in)	N/A
	X Walk 1 Slope (%)	5.0		X Walk 2 Slope (%)	N/A
	X Walk 1 X Slope (%)	2.5		X Walk 2 X Slope (%)	N/A

N/A	Ramp inside XWalk1?	N/A	N/A	Ramp inside XWalk2?	N/A
	Road Slope (%)	2.5	N/A	Clear Space?	N/A
	Road X Slope (%)	5.0	N/A	Clear Space to XWalk (in)	N/A
N/A	Any Obstructions?	N/A	N/A	Storm Grate/Utility Hazard?	N/A
	Obstruction Type			Storm Grate/Utility Type	
		N/A			N/A
			Yes	Surface Condition? (G/P)	Good

Remove & Replace Entire Ramp.
