Access Compliance Report Public Rights-of-Way (Curb Ramps)

Intersection ID: 4167 Main Street: CLAUDE_FREEMAN_DR Cross Street: W_MALLARD_CREEK_CHURCH_RD Location: E

ADA ID: DE5532A51131 Ramp Type: Perp Initial Pass/Fail: Fail Overall Compliance: No Severity Score: 8.75

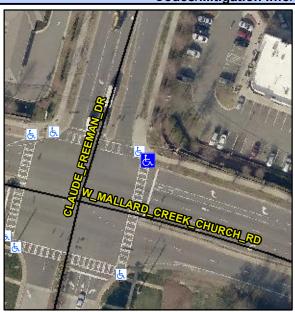
/Possible Solution		Field Measurements/Component Compliance							
Possible Solutions:		Comp	liance Description	Data	Comp	liance	Description	Data	
Remove & Replace Entire	Ramp.	N/A	Ramp Length (in)	74.5	Yes	Ramp	Slope (%)	5.3	
1	•	No	Ramp Width (in)	46.0	Yes	Ramp	XSlope (%)	2.0	
		N/A	Flare Type LT	N/A	N/A	Flare	Type RT	N/A	
		N/A	Flare Slope LT (%)	N/A	N/A	Flare	Slope RT (%)	N/A	
		N/A	Flare Traversable LT?	N/A	N/A	Flare	Traversable RT?	N/A	
		N/A	Landing Length (in)	N/A	N/A	DWS	Provided?	N/A	
Surveyor Notes:		N/A	Landing Width (in)	N/A	N/A	DWS	Contrast?	N/A	
N/A		N/A	Landing Slope (%)	N/A	N/A	DWS	Length (in)	N/A	
		N/A	Landing X Slope (%)	N/A	N/A	DWS	Full Width?	N/A	
i		N/A	Landing Curb? (Y/N)	N/A	N/A	DWS	Offset (in)	N/A	
		N/A	Shared Landing?	N/A					
PROW/ADA:		N/A	Gutter Ponding?	N/A	N/A	Gutte	r Slope (%)	N/A	
R304.5.1		N/A	Gutter Lip Ht (in)	N/A	N/A	Gutte	r X Slope (%)	N/A	
		N/A	Painted X Walk1?	Yes	N/A	Paint	ed X Walk2?	N/A

X Walk 1 Direction	To SW		X Wa	lk 2 Direction	N/A	
		N/A	X Walk 1 Width (in)	105.5	N/A	X Wa	lk 2 Width (in)	N/A	
			X Walk 1 Slope (%)	0.9		X Wa	lk 2 Slope (%)	N/A	
			X Walk 1 X Slope (%)	0.8		X Wa	lk 2 X Slope (%)	N/A	
		N/A	Ramp inside XWalk1?	Yes	N/A	Ramp	inside XWalk2?	N/A	
			Road Slope (%)	N/A	N/A	Clear	Space?	N/A	
			Road X Slope (%)	N/A	N/A	Clear	Space to XWalk (in)	N/A	
		N/A	Any Obstructions?	N/A	N/A	Storm	n Grate/Utility Hazard?	N/A	
Total Cost:	\$ 1850.00		Obstruction Type		l	Storm	n Grate/Utility Type		
				N/A				N/A
