Access Compliance Report

Public Rights-of-Way

(Curb Ramps)

Intersection ID: 10020183	Main Street: AUDUBON_PARK_DR	Cross Street: PIEDMONT_PARK_DR	Location: E
ADA ID: DE55B74DBF81	Ramp Type: Directional1	Initial Pass/Fail: Fail	Overall Compliance: No
Codes/Mitigation Info/Possible Solution		Field Measurements/Component Compliance	
Severity Score: 1.25

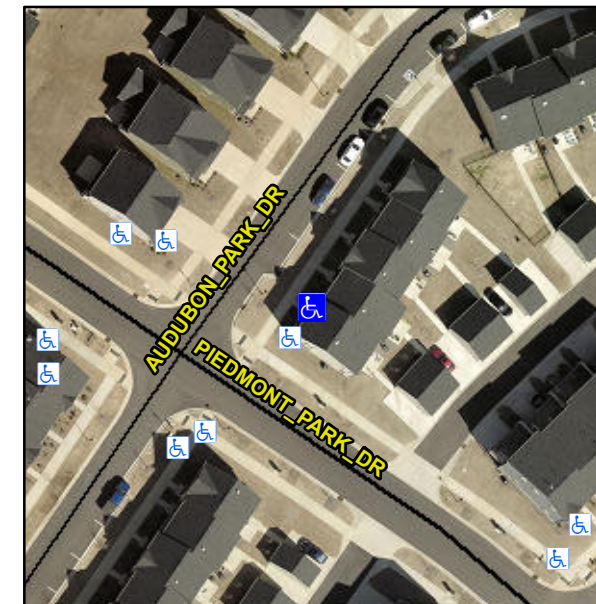
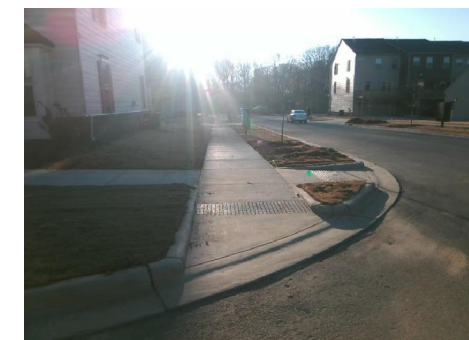
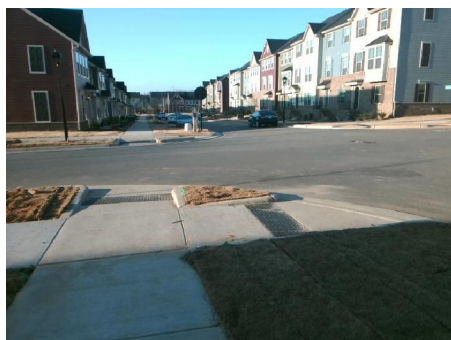
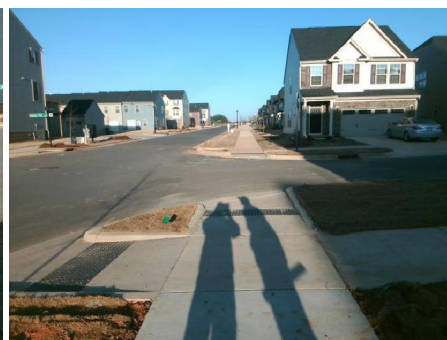
Compliance	Description	Data	Compliance	Description	Data
N/A	Ramp Length (in)	73.0	N/A	Grade Break?	N/A
Yes	Ramp Width (in)	72.0	N/A	Grade Break Slope (%)	0.0
Yes	Ramp Slope (%)	3.9	N/A	Grade Break XSlope (%)	0.0
No	Ramp XSlope (%)	2.1			
N/A	Flare Type LT	N/A	N/A	Flare Type RT	N/A
N/A	Flare Slope LT (%)	N/A	N/A	Flare Slope RT (%)	0.0
N/A	Flare Traversable LT?	N/A	N/A	Flare Traversable RT?	N/A
N/A	Landing Length (in)	0.0	N/A	DWS Provided?	N/A
N/A	Landing Width (in)	0.0	N/A	DWS Contrast?	N/A
N/A	Landing Slope (%)	0.0	N/A	DWS Length (in)	N/A
N/A	Landing X Slope (%)	0.0	N/A	DWS Full Width?	N/A
N/A	Landing Curb? (Y/N)	N/A	N/A	DWS Offset LT (in)	N/A
N/A	Shared Landing?	N/A	N/A	DWS Offset RT (in)	N/A
N/A	Gutter Ponding?	0.0	N/A	Gutter Slope (%)	N/A
N/A	Gutter Lip Ht (in)	0.0	N/A	Gutter X Slope (%)	N/A
N/A	Painted X Walk1?	No		Road Slope (%)	4.0
	X Walk 1 Direction	To NW		Road X Slope (%)	0.0
	X Walk 1 Width (in)	N/A		Clear Space?	N/A

X Walk 1 Slope (%)	4.0	N/A	Clear Space to XWalk (in)	N/A
	X Walk 1 X Slope (%)	0.0	N/A	Storm Grate/Utility Hazard?	N/A
N/A	Ramp inside XWalk1?	N/A		Storm Grate/Utility Type	
N/A	Any Obstructions?	N/A			N/A
	Obstruction Type		Yes	Surface Condition? (G/P)	Good
			N/A	Curb Slope (%)	1.8

Possible Solutions:

Remove & Replace Entire Ramp.

PROW/ADA:

R304.5.3
