Intersection ID: 31236	Main Street: AVONLEA_CT	Cross Street: STEEPLEGLLEN_CT	Location:	NW
ADA ID: DE685F667DFD	Ramp Type: PerpDiag	Initial Pass/Fail: Fail	Overall Compliance: No	Severity Score: 8.75

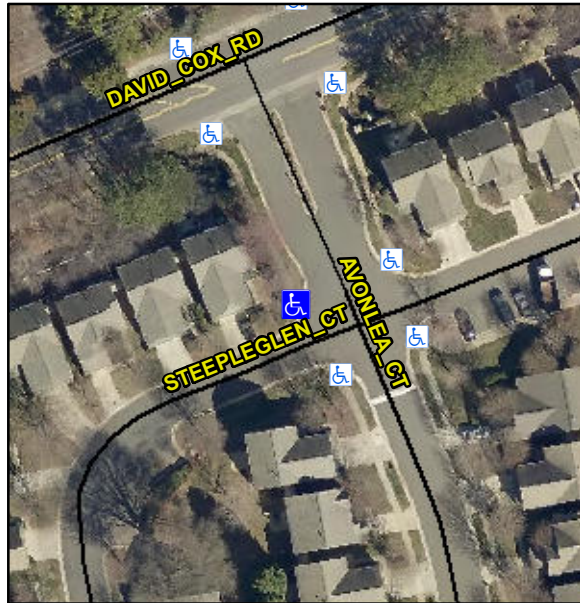
Not Found, R304.5.1

Compliance	Description	Data	Compliance	Description	Data
N/A	Ramp Length (in)	46.5	Yes	Ramp Slope (%)	5.9
No	Ramp Width (in)	45.0	Yes	Ramp XSlope (%)	0.9
N/A	Flare Type LT	N/A	N/A	Flare Type RT	N/A
N/A	Flare Slope LT (%)	N/A	N/A	Flare Slope RT (%)	N/A
N/A	Flare Traversable LT?	N/A	N/A	Flare Traversable RT?	N/A
N/A	Landing Length (in)	N/A	N/A	DWS Provided?	N/A
N/A	Landing Width (in)	N/A	N/A	DWS Contrast?	N/A
N/A	Landing Slope (%)	N/A	N/A	DWS Length (in)	N/A
N/A	Landing X Slope (%)	N/A	N/A	DWS Full Width?	N/A
N/A	Landing Curb? (Y/N)	N/A	N/A	DWS Offset (in)	N/A
N/A	Shared Landing?	N/A			
N/A	Gutter Ponding?	N/A	N/A	Gutter Slope (%)	N/A
N/A	Gutter Lip Ht (in)	N/A	N/A	Gutter X Slope (%)	N/A
N/A	Painted X Walk1?	No	N/A	Painted X Walk2?	No
	X Walk 1 Direction	To S		X Walk 2 Direction	To E
N/A	X Walk 1 Width (in)	N/A	N/A	X Walk 2 Width (in)	N/A
	X Walk 1 Slope (%)	0.7		X Walk 2 Slope (%)	1.0
	X Walk 1 X Slope (%)	0.4		X Walk 2 X Slope (%)	0.1

N/A	Ramp inside XWalk1?	N/A	N/A	Ramp inside XWalk2?	N/A
	Road Slope (%)	0.4	N/A	Clear Space?	N/A
	Road X Slope (%)	0.0	N/A	Clear Space to XWalk (in)	N/A
N/A	Any Obstructions?	N/A	N/A	Storm Grate/Utility Hazard?	N/A
	Obstruction Type			Storm Grate/Utility Type	
		N/A			N/A
			Yes	Surface Condition? (G/P)	Good

Remove & Replace Curb Ramp With Two New Directional Ramps or Equivalent.
