Access Compliance Report

Public Rights-of-Way

(Curb Ramps)

Intersection ID: 31624	Main Street: BRADFORD_DR	Cross Street: THOMASBORO_DR	Location: SE
ADA ID: DE77A6057651	Ramp Type: Perp	Initial Pass/Fail: Fail	Overall Compliance: No
Severity Score: 42.5			
Codes/Mitigation Info/Possible Solution		Field Measurements/Component Compliance

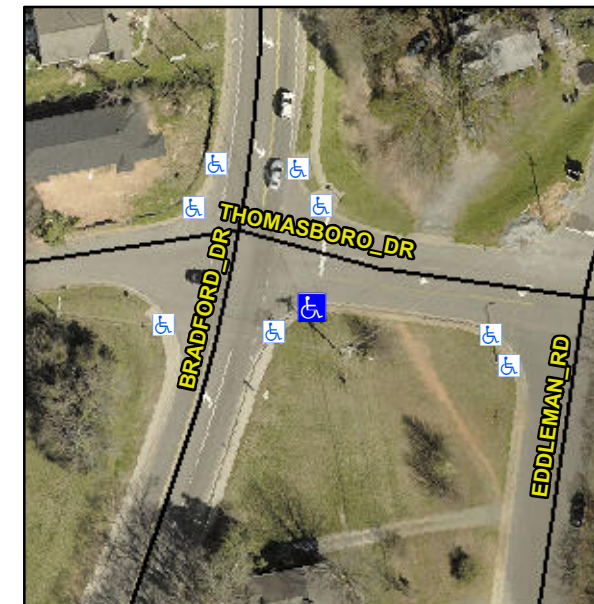
Not Found, R304.5.1, R304.2.2

Compliance	Description	Data	Compliance	Description	Data
N/A	Ramp Length (in)	37.0	No	Ramp Slope (%)	13.1
No	Ramp Width (in)	32.0	Yes	Ramp XSlope (%)	0.5
N/A	Flare Type LT	N/A	N/A	Flare Type RT	N/A
N/A	Flare Slope LT (%)	N/A	N/A	Flare Slope RT (%)	N/A
N/A	Flare Traversable LT?	N/A	N/A	Flare Traversable RT?	N/A
N/A	Landing Length (in)	N/A	N/A	DWS Provided?	N/A
N/A	Landing Width (in)	N/A	N/A	DWS Contrast?	N/A
N/A	Landing Slope (%)	N/A	N/A	DWS Length (in)	N/A
N/A	Landing X Slope (%)	N/A	N/A	DWS Full Width?	N/A
N/A	Landing Curb? (Y/N)	N/A	N/A	DWS Offset (in)	N/A
N/A	Shared Landing?	N/A			
N/A	Gutter Ponding?	N/A	N/A	Gutter Slope (%)	N/A
N/A	Gutter Lip Ht (in)	N/A	N/A	Gutter X Slope (%)	N/A
N/A	Painted X Walk1?	No	N/A	Painted X Walk2?	N/A
	X Walk 1 Direction	To N		X Walk 2 Direction	N/A
N/A	X Walk 1 Width (in)	N/A	N/A	X Walk 2 Width (in)	N/A
	X Walk 1 Slope (%)	0.1		X Walk 2 Slope (%)	N/A
	X Walk 1 X Slope (%)	0.6		X Walk 2 X Slope (%)	N/A

Remove & Replace Entire Ramp.

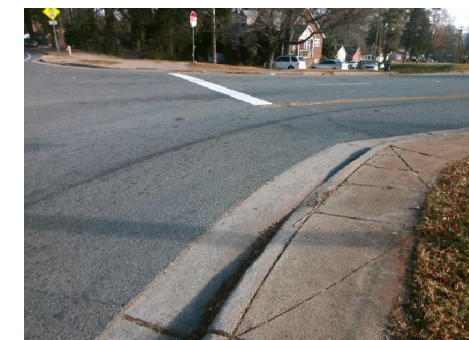
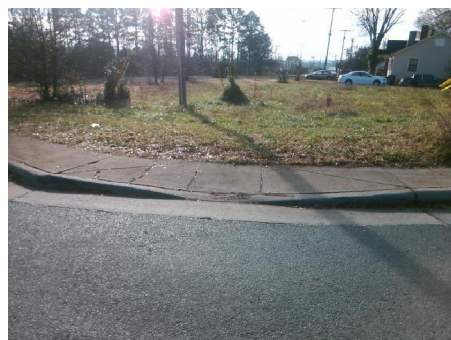
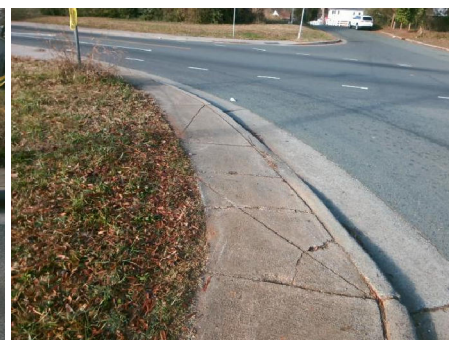
N/A	Ramp inside XWalk1?	N/A	N/A	Ramp inside XWalk2?	N/A
	Road Slope (%)	N/A	N/A	Clear Space?	N/A
	Road X Slope (%)	N/A	N/A	Clear Space to XWalk (in)	N/A
N/A	Any Obstructions?	N/A	N/A	Storm Grate/Utility Hazard?	N/A
	Obstruction Type			Storm Grate/Utility Type	
		N/A			N/A
		Yes		Surface Condition? (G/P)	Good
