# Access Compliance Report

## Public Rights-of-Way (Curb Ramps)

| Intersection ID: 42581 | Main Street: GERALDINE_POWE_DR | Cross Street: RISING_OAK_DR | Location: SW |
| ADA ID: DE7E981FA06F | Ramp Type: BlendTrans1 | Initial Pass/Fail: Pass | Overall Compliance: No |

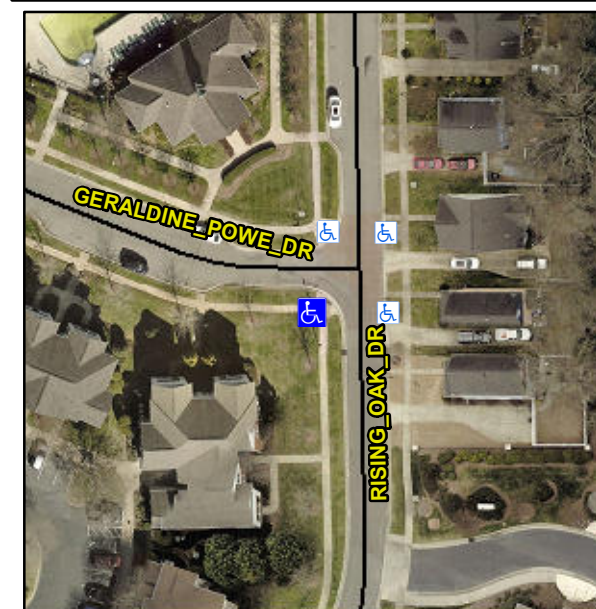
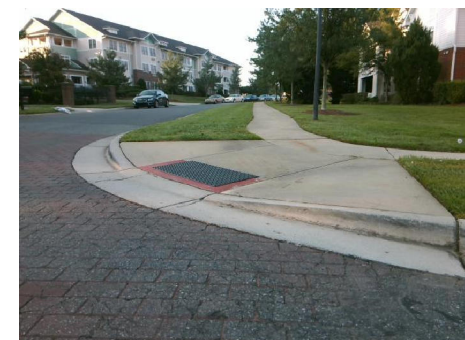
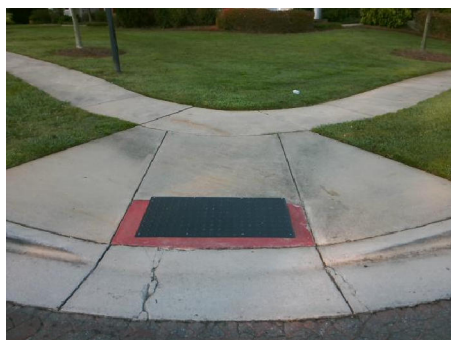
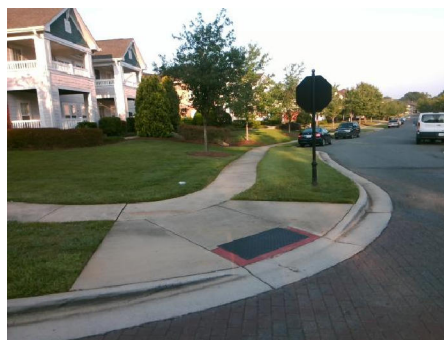
**Not Found, R304.5.3, R304.2.2-Perp, R304.3.2-Para, R305.1.4, R305.2, R302.7.2**

| Compliance | Description | Data | Compliance | Description | Data |
|---|---|---|---|---|---|
| Yes | Ramp Width (in) | 59.0 | No | BlendTrans XSlope (%) | 4.0 |
| No | Landing Slope (%) | 2.6 | Yes | DWS Length (in) | 24.0 |
| No | Landing X Slope (%) | 4.8 | No | DWS Full Width? | No |
| No | Gutter Lip Ht (in) | 0.5 | No | Gutter X Slope (%) | 2.7 |

**Remove & Replace Curb Ramp With Two New Directional Ramps or Equivalent. Remove & Replace Gutter.**
