# Access Compliance Report

## Public Rights-of-Way

### (Curb Ramps)

Intersection ID: 8276	Main Street: BROOKSHIRE_BV	Cross Street: N LINWOOD_AV	Location: NW
ADA ID: DE9B5B735025	Ramp Type: Perp	Initial Pass/Fail: Fail	Overall Compliance: No
Severity Score: 33.75			
Codes/Mitigation Info/Possible Solution		Field Measurements/Component Compliance

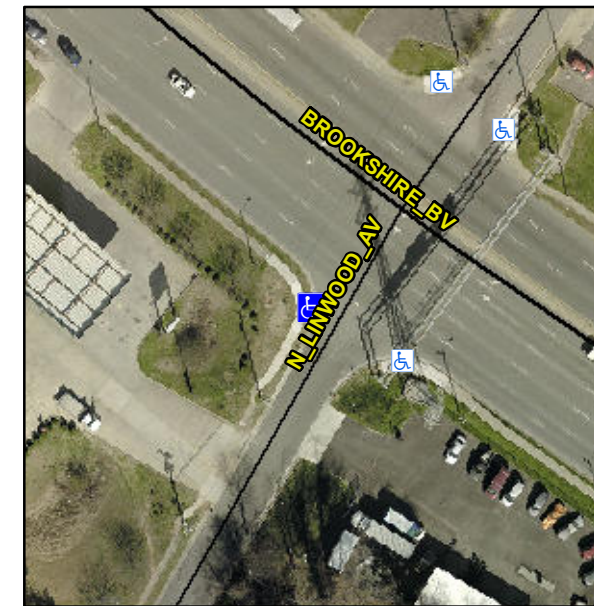
**Not Found, R304.5.1, R304.5.3**

Compliance	Description	Data	Compliance	Description	Data
N/A	Ramp Length (in)	48.0	Yes	Ramp Slope (%)	6.3
No	Ramp Width (in)	41.0	No	Ramp XSlope (%)	7.1
N/A	Flare Type LT	N/A	N/A	Flare Type RT	N/A
N/A	Flare Slope LT (%)	N/A	N/A	Flare Slope RT (%)	N/A
N/A	Flare Traversable LT?	N/A	N/A	Flare Traversable RT?	N/A
N/A	Landing Length (in)	N/A	N/A	DWS Provided?	N/A
N/A	Landing Width (in)	N/A	N/A	DWS Contrast?	N/A
N/A	Landing Slope (%)	N/A	N/A	DWS Length (in)	N/A
N/A	Landing X Slope (%)	N/A	N/A	DWS Full Width?	N/A
N/A	Landing Curb? (Y/N)	N/A	N/A	DWS Offset (in)	N/A
N/A	Shared Landing?	N/A			
N/A	Gutter Ponding?	N/A	N/A	Gutter Slope (%)	N/A
N/A	Gutter Lip Ht (in)	N/A	N/A	Gutter X Slope (%)	N/A
N/A	Painted X Walk1?	No	N/A	Painted X Walk2?	N/A
	X Walk 1 Direction	To SE		X Walk 2 Direction	N/A
N/A	X Walk 1 Width (in)	N/A	N/A	X Walk 2 Width (in)	N/A
	X Walk 1 Slope (%)	4.9		X Walk 2 Slope (%)	N/A
	X Walk 1 X Slope (%)	7.6		X Walk 2 X Slope (%)	N/A

N/A	Ramp inside XWalk1?	N/A	N/A	Ramp inside XWalk2?	N/A
	Road Slope (%)	N/A	N/A	Clear Space?	N/A
	Road X Slope (%)	N/A	N/A	Clear Space to XWalk (in)	N/A
N/A	Any Obstructions?	N/A	N/A	Storm Grate/Utility Hazard?	N/A
	Obstruction Type			Storm Grate/Utility Type	
		N/A			N/A
			Yes	Surface Condition? (G/P)	Good

**Remove & Replace Entire Ramp.**

Total Cost: \$ 1850.00
