# Access Compliance Report

## Public Rights-of-Way

### (Curb Ramps)

Intersection ID: 50464	Main Street: LENOX_POINTE_DR	Cross Street: SANDY_PORTER_RD	Location: W
ADA ID: DEA80EEC519A	Ramp Type: Perp	Initial Pass/Fail: Fail	Overall Compliance: No
Severity Score: 1.25			
Codes/Mitigation Info/Possible Solution		Field Measurements/Component Compliance

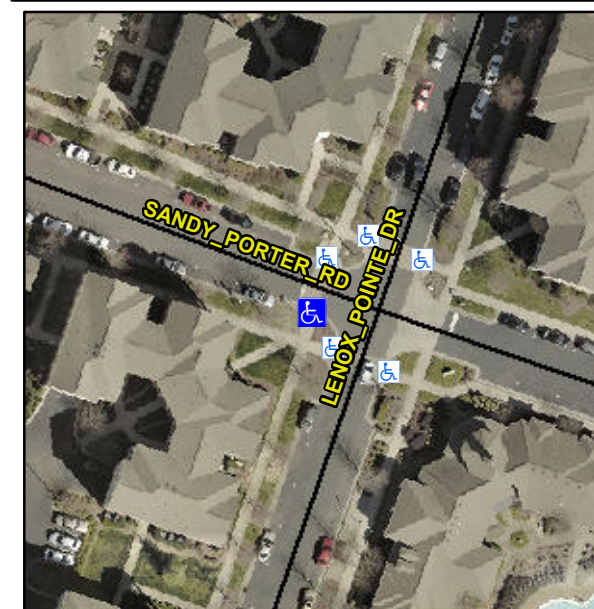
**Not Found, R304.5.3**

Compliance	Description	Data	Compliance	Description	Data
N/A	Ramp Length (in)	71.5	Yes	Ramp Slope (%)	6.3
Yes	Ramp Width (in)	48.0	No	Ramp XSlope (%)	3.5
N/A	Flare Type LT	N/A	N/A	Flare Type RT	N/A
N/A	Flare Slope LT (%)	N/A	N/A	Flare Slope RT (%)	N/A
N/A	Flare Traversable LT?	N/A	N/A	Flare Traversable RT?	N/A
N/A	Landing Length (in)	N/A	N/A	DWS Provided?	N/A
N/A	Landing Width (in)	N/A	N/A	DWS Contrast?	N/A
N/A	Landing Slope (%)	N/A	N/A	DWS Length (in)	N/A
N/A	Landing X Slope (%)	N/A	N/A	DWS Full Width?	N/A
N/A	Landing Curb? (Y/N)	N/A	N/A	DWS Offset (in)	N/A
N/A	Shared Landing?	N/A			
N/A	Gutter Ponding?	N/A	N/A	Gutter Slope (%)	N/A
N/A	Gutter Lip Ht (in)	N/A	N/A	Gutter X Slope (%)	N/A
N/A	Painted X Walk1?	Yes	N/A	Painted X Walk2?	N/A
	X Walk 1 Direction	To NE		X Walk 2 Direction	N/A
N/A	X Walk 1 Width (in)	144.0	N/A	X Walk 2 Width (in)	N/A
	X Walk 1 Slope (%)	7.4		X Walk 2 Slope (%)	N/A
	X Walk 1 X Slope (%)	4.2		X Walk 2 X Slope (%)	N/A

N/A	Ramp inside XWalk1?	Yes	N/A	Ramp inside XWalk2?	N/A
	Road Slope (%)	N/A	N/A	Clear Space?	N/A
	Road X Slope (%)	N/A	N/A	Clear Space to XWalk (in)	N/A
N/A	Any Obstructions?	N/A	N/A	Storm Grate/Utility Hazard?	N/A
	Obstruction Type			Storm Grate/Utility Type	
		N/A			N/A
			Yes	Surface Condition? (G/P)	Good

Possible Solutions:

**Remove & Replace Entire Ramp.**

Total Cost: \$ 1850.00
