Access Compliance Report

Public Rights-of-Way

(Curb Ramps)

Intersection ID: 18818	Main Street: BEAM_RD	Cross Street: SHOPTON_RD	Location: SW
ADA ID: DEA828F79E91	Ramp Type: Perp	Initial Pass/Fail: Fail	Overall Compliance: No
Codes/Mitigation Info/Possible Solution		Field Measurements/Component Compliance	
Severity Score: 12.5

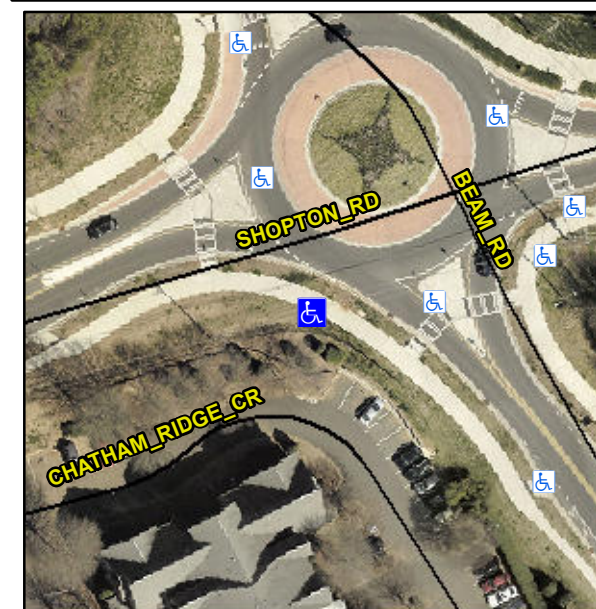
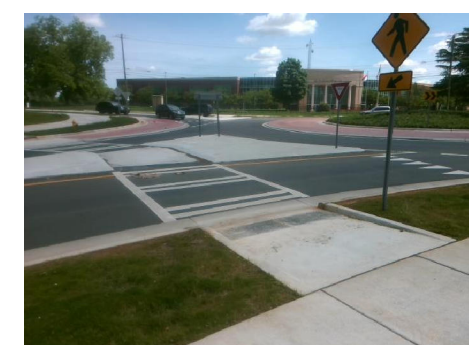
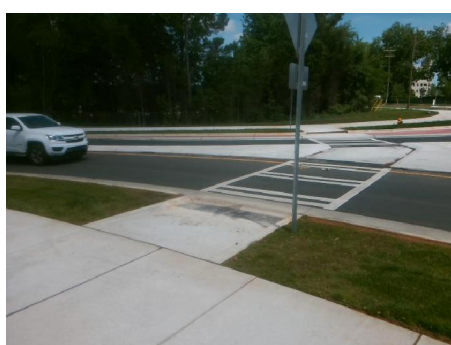
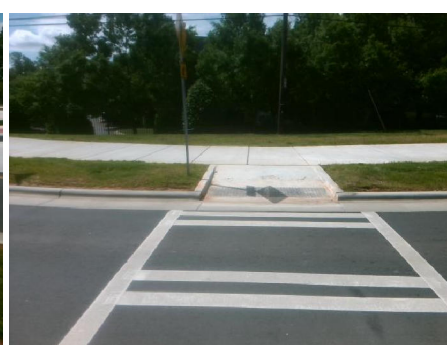
Compliance	Description	Data	Compliance	Description	Data
N/A	Ramp Length (in)	94.0	No	Ramp Slope (%)	9.0
Yes	Ramp Width (in)	93.0	Yes	Ramp XSlope (%)	0.3
N/A	Flare Type LT	N/A	N/A	Flare Type RT	N/A
N/A	Flare Slope LT (%)	N/A	N/A	Flare Slope RT (%)	N/A
N/A	Flare Traversable LT?	N/A	N/A	Flare Traversable RT?	N/A
N/A	Landing Length (in)	N/A	N/A	DWS Provided?	N/A
N/A	Landing Width (in)	N/A	N/A	DWS Contrast?	N/A
N/A	Landing Slope (%)	N/A	N/A	DWS Length (in)	N/A
N/A	Landing X Slope (%)	N/A	N/A	DWS Full Width?	N/A
N/A	Landing Curb? (Y/N)	N/A	N/A	DWS Offset (in)	N/A
N/A	Shared Landing?	N/A			
N/A	Gutter Ponding?	N/A	N/A	Gutter Slope (%)	N/A
N/A	Gutter Lip Ht (in)	N/A	N/A	Gutter X Slope (%)	N/A
N/A	Painted X Walk1?	Yes	N/A	Painted X Walk2?	N/A
	X Walk 1 Direction	To N		X Walk 2 Direction	N/A
N/A	X Walk 1 Width (in)	111.0	N/A	X Walk 2 Width (in)	N/A
	X Walk 1 Slope (%)	1.8		X Walk 2 Slope (%)	N/A
	X Walk 1 X Slope (%)	1.2		X Walk 2 X Slope (%)	N/A

N/A	Ramp inside XWalk1?	Yes	N/A	Ramp inside XWalk2?	N/A
	Road Slope (%)	N/A	N/A	Clear Space?	N/A
	Road X Slope (%)	N/A	N/A	Clear Space to XWalk (in)	N/A
N/A	Any Obstructions?	N/A	N/A	Storm Grate/Utility Hazard?	N/A
	Obstruction Type			Storm Grate/Utility Type	
		N/A			N/A
			Yes	Surface Condition? (G/P)	Good

Possible Solutions:

Remove & Replace Entire Ramp.

R304.2.2
