Access Compliance Report

Public Rights-of-Way (Curb Ramps)

Intersection ID: 17513	Main Street: PROVIDENCE_DR	Cross Street: PROVIDENCE_RD	Location: SW
ADA ID: DEA893E4B565	Ramp Type: Perp	Initial Pass/Fail: Fail	Overall Compliance: No
		Severity Score: 37.5

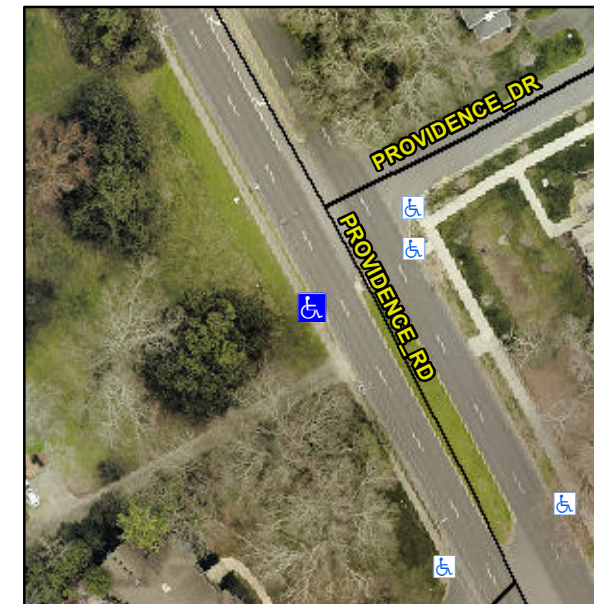
Not Found, R304.2.2, R304.5.3

Compliance	Description	Data	Compliance	Description	Data
N/A	Ramp Length (in)	24.0	No	Ramp Slope (%)	8.9
Yes	Ramp Width (in)	48.0	No	Ramp XSlope (%)	7.8
N/A	Flare Type LT	N/A	N/A	Flare Type RT	N/A
N/A	Flare Slope LT (%)	N/A	N/A	Flare Slope RT (%)	N/A
N/A	Flare Traversable LT?	N/A	N/A	Flare Traversable RT?	N/A
N/A	Landing Length (in)	N/A	N/A	DWS Provided?	N/A
N/A	Landing Width (in)	N/A	N/A	DWS Contrast?	N/A
N/A	Landing Slope (%)	N/A	N/A	DWS Length (in)	N/A
N/A	Landing X Slope (%)	N/A	N/A	DWS Full Width?	N/A
N/A	Landing Curb? (Y/N)	N/A	N/A	DWS Offset (in)	N/A
N/A	Shared Landing?	N/A			
N/A	Gutter Ponding?	N/A	N/A	Gutter Slope (%)	N/A
N/A	Gutter Lip Ht (in)	N/A	N/A	Gutter X Slope (%)	N/A
N/A	Painted X Walk1?	No	N/A	Painted X Walk2?	N/A
	X Walk 1 Direction	To NE		X Walk 2 Direction	N/A
N/A	X Walk 1 Width (in)	N/A	N/A	X Walk 2 Width (in)	N/A
	X Walk 1 Slope (%)	3.2		X Walk 2 Slope (%)	N/A
	X Walk 1 X Slope (%)	7.6		X Walk 2 X Slope (%)	N/A

N/A	Ramp inside XWalk1?	N/A	N/A	Ramp inside XWalk2?	N/A
	Road Slope (%)	N/A	N/A	Clear Space?	N/A
	Road X Slope (%)	N/A	N/A	Clear Space to XWalk (in)	N/A
N/A	Any Obstructions?	N/A	N/A	Storm Grate/Utility Hazard?	N/A
	Obstruction Type			Storm Grate/Utility Type	
		N/A			N/A
			Yes	Surface Condition? (G/P)	Good

Remove & Replace Entire Ramp.
