Access Compliance Report

Public Rights-of-Way

(Curb Ramps)

Intersection ID: 25211	Main Street: SMITH_RD	Cross Street: SOUTHBRIDGE_FOREST_DR	Location: NW
ADA ID: DEAA81190FD7	Ramp Type: Perp	Initial Pass/Fail: Fail	Overall Compliance: No
		Severity Score: 10

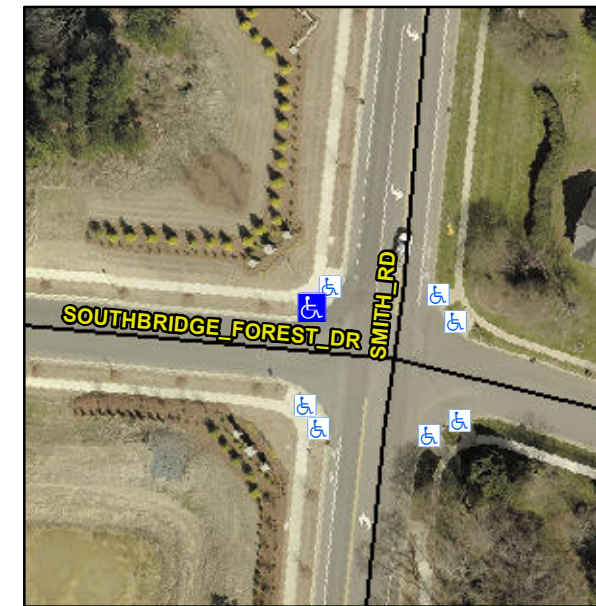
Compliance	Description	Data	Compliance	Description	Data
N/A	Ramp Length (in)	95.0	Yes	Ramp Slope (%)	6.2
No	Ramp Width (in)	46.5	No	Ramp XSlope (%)	2.5
N/A	Flare Type LT	N/A	N/A	Flare Type RT	N/A
N/A	Flare Slope LT (%)	N/A	N/A	Flare Slope RT (%)	N/A
N/A	Flare Traversable LT?	N/A	N/A	Flare Traversable RT?	N/A
N/A	Landing Length (in)	N/A	N/A	DWS Provided?	N/A
N/A	Landing Width (in)	N/A	N/A	DWS Contrast?	N/A
N/A	Landing Slope (%)	N/A	N/A	DWS Length (in)	N/A
N/A	Landing X Slope (%)	N/A	N/A	DWS Full Width?	N/A
N/A	Landing Curb? (Y/N)	N/A	N/A	DWS Offset (in)	N/A
N/A	Shared Landing?	N/A			
N/A	Gutter Ponding?	N/A	N/A	Gutter Slope (%)	N/A
N/A	Gutter Lip Ht (in)	N/A	N/A	Gutter X Slope (%)	N/A
N/A	Painted X Walk1?	No	N/A	Painted X Walk2?	N/A
	X Walk 1 Direction	To SW		X Walk 2 Direction	N/A
N/A	X Walk 1 Width (in)	N/A	N/A	X Walk 2 Width (in)	N/A
	X Walk 1 Slope (%)	0.7		X Walk 2 Slope (%)	N/A
	X Walk 1 X Slope (%)	2.1		X Walk 2 X Slope (%)	N/A

N/A	Ramp inside XWalk1?	N/A	N/A	Ramp inside XWalk2?	N/A
	Road Slope (%)	N/A	N/A	Clear Space?	N/A
	Road X Slope (%)	N/A	N/A	Clear Space to XWalk (in)	N/A
N/A	Any Obstructions?	N/A	N/A	Storm Grate/Utility Hazard?	N/A
	Obstruction Type			Storm Grate/Utility Type	
		N/A			N/A
			Yes	Surface Condition? (G/P)	Good

Remove & Replace Entire Ramp.

R304.5.1, R304.5.3
