# Access Compliance Report

## Public Rights-of-Way

### (Curb Ramps)

Intersection ID: 10270	Main Street: FONTANA_AV	Cross Street: SPRING_ST	Location: NW
ADA ID: DEAF3775CCBF	Ramp Type: Perp	Initial Pass/Fail: Fail	Overall Compliance: No
		Severity Score: 1.25

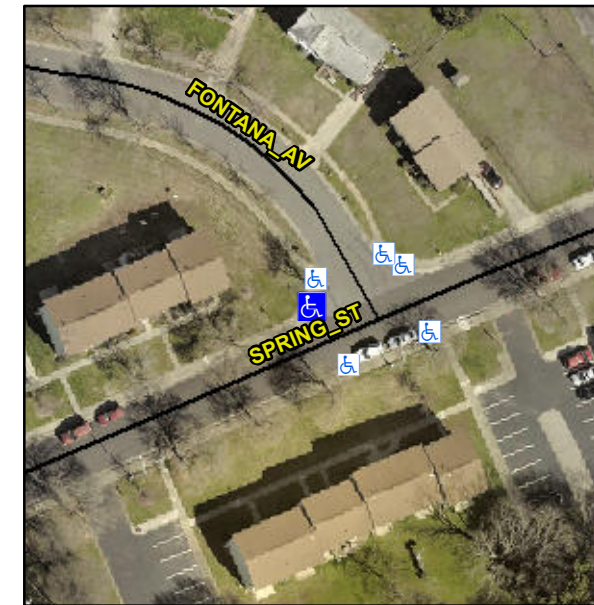
Compliance	Description	Data	Compliance	Description	Data
N/A	Ramp Length (in)	61.0	Yes	Ramp Slope (%)	7.6
Yes	Ramp Width (in)	48.0	Yes	Ramp XSlope (%)	3.2
N/A	Flare Type LT	N/A	N/A	Flare Type RT	N/A
N/A	Flare Slope LT (%)	N/A	N/A	Flare Slope RT (%)	N/A
N/A	Flare Traversable LT?	N/A	N/A	Flare Traversable RT?	N/A
N/A	Landing Length (in)	N/A	N/A	DWS Provided?	N/A
N/A	Landing Width (in)	N/A	N/A	DWS Contrast?	N/A
N/A	Landing Slope (%)	N/A	N/A	DWS Length (in)	N/A
N/A	Landing X Slope (%)	N/A	N/A	DWS Full Width?	N/A
N/A	Landing Curb? (Y/N)	N/A	N/A	DWS Offset (in)	N/A
N/A	Shared Landing?	N/A			
N/A	Gutter Ponding?	N/A	N/A	Gutter Slope (%)	N/A
N/A	Gutter Lip Ht (in)	1.0	N/A	Gutter X Slope (%)	N/A
N/A	Painted X Walk1?	No	N/A	Painted X Walk2?	N/A
	X Walk 1 Direction	To S		X Walk 2 Direction	N/A
N/A	X Walk 1 Width (in)	N/A	N/A	X Walk 2 Width (in)	N/A
	X Walk 1 Slope (%)	3.0		X Walk 2 Slope (%)	N/A
	X Walk 1 X Slope (%)	3.4		X Walk 2 X Slope (%)	N/A

N/A	Ramp inside XWalk1?	N/A	N/A	Ramp inside XWalk2?	N/A
	Road Slope (%)	N/A	N/A	Clear Space?	N/A
	Road X Slope (%)	N/A	N/A	Clear Space to XWalk (in)	N/A
N/A	Any Obstructions?	N/A	N/A	Storm Grate/Utility Hazard?	N/A
	Obstruction Type			Storm Grate/Utility Type	
		N/A			N/A
			Yes	Surface Condition? (G/P)	Good

Possible Solutions:

**Remove & Replace Entire Ramp.**

Total Cost: \$ 1850.00

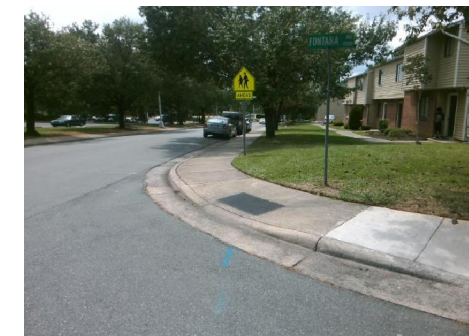
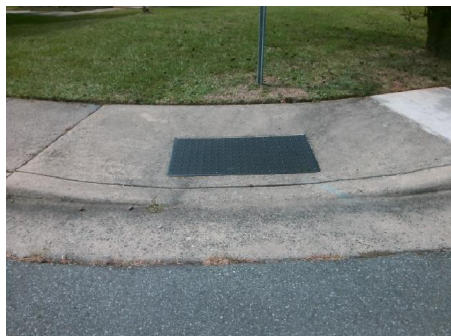
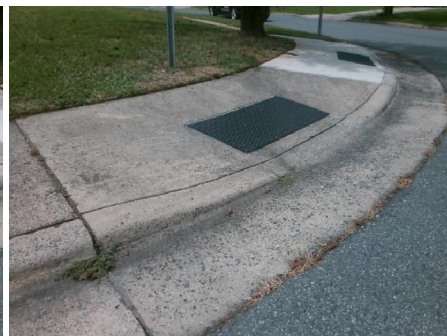
Street 1 Name	SPRING ST
Stop Condition-Street 2	None
Street 2 Name	N/A
Stop Condition-Street 1	N/A
