# Access Compliance Report

## Public Rights-of-Way

### (Curb Ramps)

| Intersection ID: 12998 | Main Street: 5TH_ST | Cross Street: MCDOWELL_ST | Location: | N |

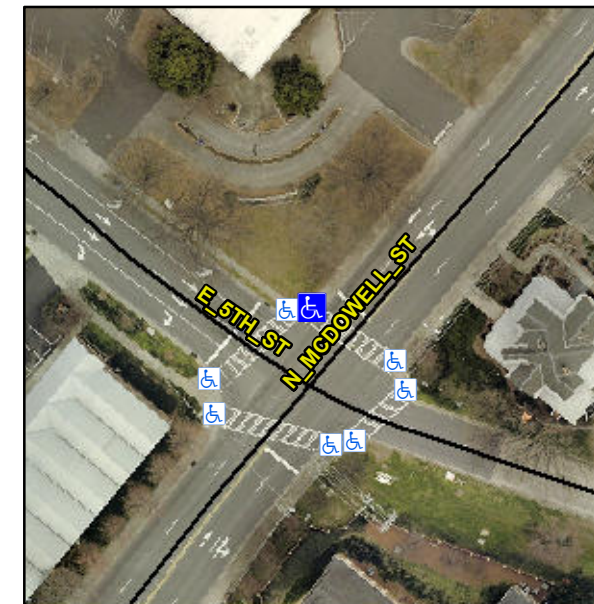
| ADA ID: DEB49ACEB656 | Ramp Type: Perp | Initial Pass/Fail: Fail | Overall Compliance: No | Severity Score: 37.5 |

**Not Found, R304.2.2, R304.5.3**

| Compliance | Description | Data | Compliance | Description | Data |
|---|---|---|---|---|---|
| N/A | Ramp Length (in) | 76.0 | No | Ramp Slope (%) | 9.3 |
| Yes | Ramp Width (in) | 55.0 | No | Ramp XSlope (%) | 7.1 |

**Remove & Replace Entire Ramp.**

Total Cost: \$ 1850.00
