Access Compliance Report

Public Rights-of-Way

(Curb Ramps)

Intersection ID: 8889	Main Street: BENNETT_ST	Cross Street: N_TRYON_ST	Location: NE
ADA ID: DEB866DD0373	Ramp Type: ParaDiag	Initial Pass/Fail: Fail	Overall Compliance: No
		Severity Score: 25

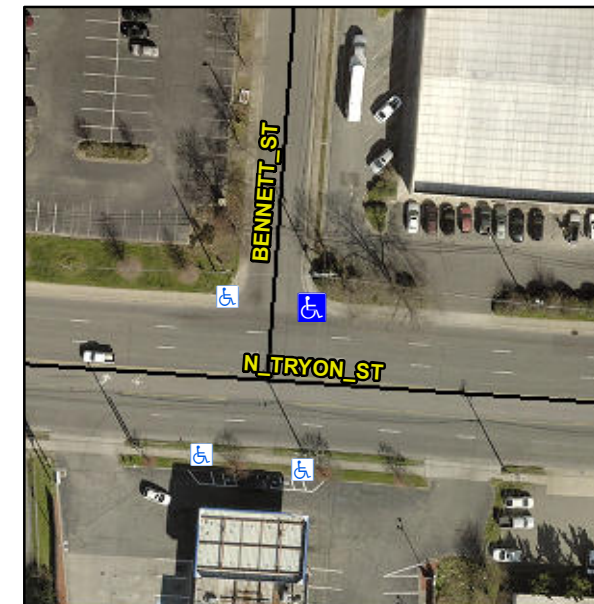
LT RP < 5%

R304.3.2

Compliance	Description	Data	Compliance	Description	Data
N/A	Ramp Length LT (in)	38.5	N/A	Ramp Length RT (in)	38.0
Yes	Ramp Width LT (in)	56.0	Yes	Ramp Width RT (in)	59.0
Yes	Ramp Slope LT (%)	2.3	No	Ramp Slope RT (%)	13.8
Yes	Ramp XSlope LT (%)	1.1	Yes	Ramp XSlope RT (%)	0.5
N/A	Landing Length (in)	N/A	N/A	DWS Provided?	N/A
N/A	Landing Width (in)	N/A	N/A	DWS Contrast?	N/A
N/A	Landing Slope (%)	N/A	N/A	DWS Length (in)	N/A
N/A	Landing X Slope (%)	N/A	N/A	DWS Full Width?	N/A
N/A	Landing Curb? (Y/N)	N/A	N/A	DWS Offset (in)	N/A
N/A	Shared Landing?	N/A			
N/A	Gutter Ponding?	N/A	N/A	Gutter Slope (%)	N/A
N/A	Gutter Lip Ht (in)	N/A	N/A	Gutter X Slope (%)	N/A
N/A	Painted X Walk1?	No	N/A	Painted X Walk2?	No
	X Walk 1 Direction	To W		X Walk 2 Direction	To S
N/A	X Walk 1 Width (in)	N/A	N/A	X Walk 2 Width (in)	N/A
	X Walk 1 Slope (%)	0.7		X Walk 2 Slope (%)	3.7
	X Walk 1 X Slope (%)	6.4		X Walk 2 X Slope (%)	0.3
N/A	Ramp inside XWalk1?	N/A	N/A	Ramp inside XWalk2?	N/A

Road Slope (%)	5.7	N/A	Clear Space?	N/A
	Road X Slope (%)	6.4	N/A	Clear Space to XWalk (in)	N/A
N/A	Any Obstructions?	N/A	N/A	Storm Grate/Utility Hazard?	N/A
	Obstruction Type			Storm Grate/Utility Type	
		N/A			N/A
			Yes	Surface Condition? (G/P)	Good
			N/A	Curb Slope (%)	25.4

Remove & Replace Curb Ramp With Two New Directional Ramps or Equivalent.

\$ 3200.00
