Access Compliance Report

Public Rights-of-Way

(Curb Ramps)

Intersection ID: 9694	Main Street: PEACEFUL_WAY_DR	Cross Street: RISING_OAK_DR	Location: W
ADA ID: DEBD5BB4A22A	Ramp Type: BlendTrans1	Initial Pass/Fail: Fail	Overall Compliance: No
Severity Score: 10			
Codes/Mitigation Info/Possible Solution		Field Measurements/Component Compliance

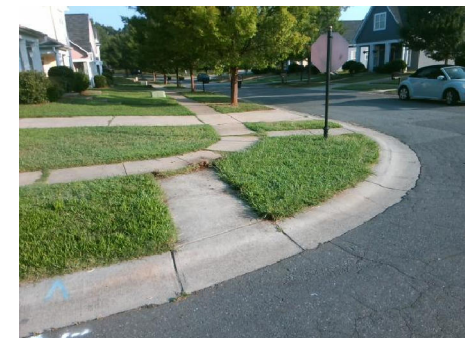
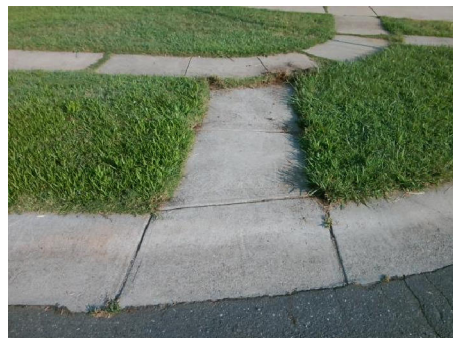
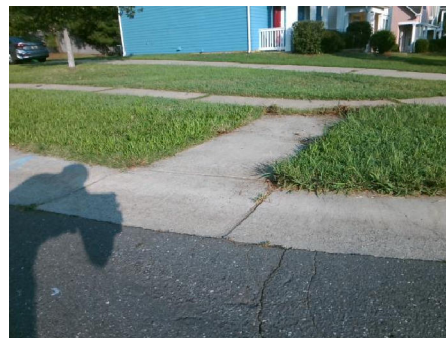
Not Found, R304.5.1, R304.5.3

Compliance	Description	Data	Compliance	Description	Data
N/A	Ramp Length (in)	90.0	Yes	BlendTrans Slope (%)	4.0
No	Ramp Width (in)	45.5	No	BlendTrans XSlope (%)	3.1
N/A	Flare Type LT	N/A	N/A	Flare Type RT	N/A
N/A	Flare Slope LT (%)	N/A	N/A	Flare Slope RT (%)	N/A
N/A	Flare Traversable LT?	N/A	N/A	Flare Traversable RT?	N/A
N/A	Landing Length (in)	N/A	N/A	DWS Provided?	N/A
N/A	Landing Width (in)	N/A	N/A	DWS Contrast?	N/A
N/A	Landing Slope (%)	N/A	N/A	DWS Length (in)	N/A
N/A	Landing X Slope (%)	N/A	N/A	DWS Full Width?	N/A
N/A	Landing Curb? (Y/N)	N/A	N/A	DWS Offset (in)	N/A
N/A	Shared Landing?	N/A			
N/A	Gutter Ponding?	N/A	N/A	Gutter Slope (%)	N/A
N/A	Gutter Lip Ht (in)	N/A	N/A	Gutter X Slope (%)	N/A
N/A	Painted X Walk1?	No	N/A	Painted X Walk2?	N/A
	X Walk 1 Direction	To S		X Walk 2 Direction	N/A
	X Walk 1 Width (in)	N/A		X Walk 2 Width (in)	N/A
	X Walk 1 Slope (%)	2.6		X Walk 2 Slope (%)	N/A
	X Walk 1 X Slope (%)	0.6		X Walk 2 X Slope (%)	N/A

N/A	Ramp inside XWalk1?	N/A	N/A	Ramp inside XWalk2?	N/A
	Road Slope (%)	0.6		Clear Space?	N/A
	Road X Slope (%)	2.6	N/A	Clear Space to XWalk (in)	N/A
N/A	Any Obstructions?	N/A	N/A	Storm Grate/Utility Hazard?	N/A
	Obstruction Type			Storm Grate/Utility Type	
		N/A			N/A
			Yes	Surface Condition? (G/P)	Good
			No	Curb Slope (%)	16.2

Possible Solutions:

Remove & Replace Curb Ramp With Two New Directional Ramps or Equivalent.
