Access Compliance Report

Public Rights-of-Way

(Curb Ramps)

| Intersection ID: 18588 | Main Street: MINUET_LN | Cross Street: SEVENTY_SEVEN_CENTER_DR | Location: SE |

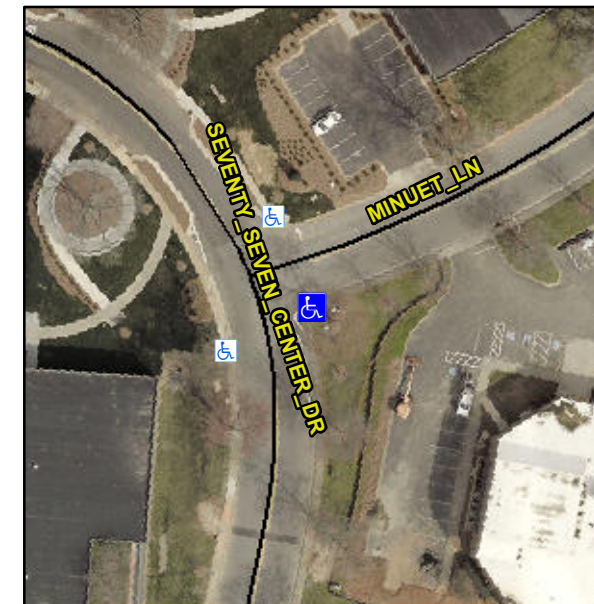
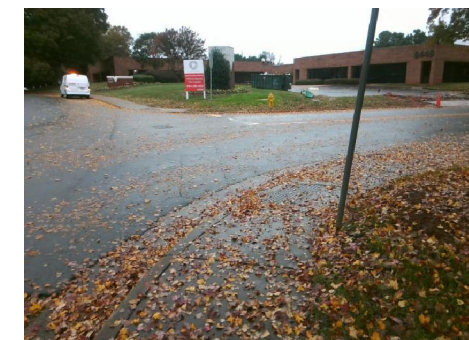
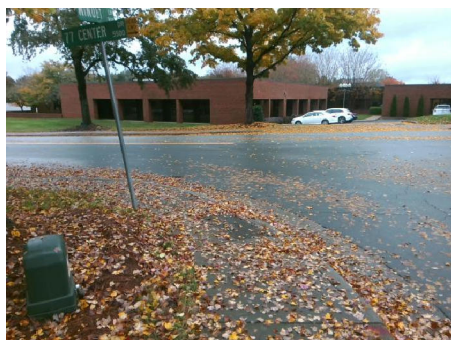
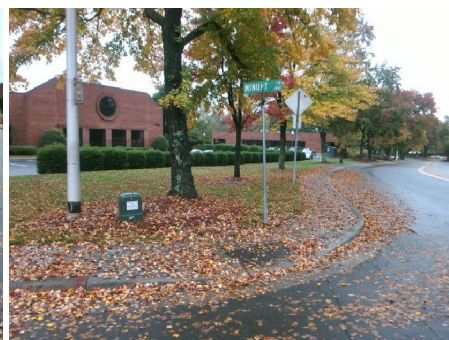
| ADA ID: DEC358B5EF62 | Ramp Type: PerpDiag | Initial Pass/Fail: Fail | Overall Compliance: No |

Not Found, R304.5.1, R304.2.2

| Compliance | Description | Data | Compliance | Description | Data |
|---|---|---|---|---|---|
| N/A | Ramp Length (in) | 50.0 | No | Ramp Slope (%) | 8.9 |
| No | Ramp Width (in) | 47.0 | Yes | Ramp XSlope (%) | 1.2 |

Remove & Replace Curb Ramp With Two New Directional Ramps or Equivalent.
