# Access Compliance Report

## Public Rights-of-Way

### (Curb Ramps)

Intersection ID: 49790	Main Street: FESCUE_CT	Cross Street: BARLEY_LN	Location:	E
ADA ID: DEC8040D9077	Ramp Type: Perp	Initial Pass/Fail: Fail	Overall Compliance: No	Severity Score: 8.75

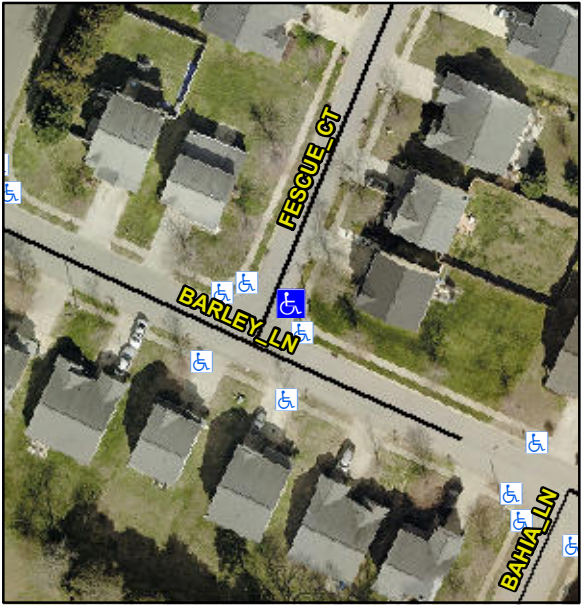
Possible Solutions:		<b>Compliance</b>	<b>Description</b>	<b>Data</b>
	<b>Remove &amp; Replace Entire Ramp.</b>		<b>Yes</b>	Ramp Length (in)	47.5
			<b>No</b>	Ramp Width (in)	47.0
			<b>N/A</b>	Flare Type LT	N/A
			<b>N/A</b>	Flare Slope LT (%)	N/A
			<b>N/A</b>	Flare Traversable LT?	N/A
			<b>N/A</b>	Landing Length (in)	N/A
			<b>N/A</b>	Landing Width (in)	N/A
			<b>N/A</b>	Landing Slope (%)	N/A
			<b>N/A</b>	Landing X Slope (%)	N/A
<p>Surveyor Notes:</p> <p><b>N/A</b></p> <p>PROW/ADA:</p> <p><b>Not Found, R304.5.1</b></p>			<b>N/A</b>	Flare Type RT	N/A
			<b>N/A</b>	Flare Slope RT (%)	N/A
			<b>N/A</b>	Flare Traversable RT?	N/A
			<b>N/A</b>	DWS Provided?	N/A
			<b>N/A</b>	DWS Contrast?	N/A
			<b>N/A</b>	DWS Length (in)	N/A
			<b>N/A</b>	DWS Full Width?	N/A
			<b>N/A</b>	DWS Offset (in)	N/A
			<b>N/A</b>	Shared Landing?	N/A

<b>N/A</b>	Gutter Ponding?	N/A
			<b>N/A</b>	Gutter Lip Ht (in)	N/A
			<b>N/A</b>	Painted X Walk1?	No
				X Walk 1 Direction	To NW
			<b>N/A</b>	X Walk 1 Width (in)	N/A
				X Walk 1 Slope (%)	2.5
				X Walk 1 X Slope (%)	3.0
			<b>N/A</b>	Ramp inside XWalk1?	N/A
			<b>N/A</b>	Road Slope (%)	N/A
			<b>N/A</b>	Road X Slope (%)	N/A
			<b>N/A</b>	Any Obstructions?	N/A
				Obstruction Type	
			<b>N/A</b>		
			<b>N/A</b>		
			<b>N/A</b>		
			<b>N/A</b>		
			<b>N/A</b>		
			<b>N/A</b>		
			<b>N/A</b>		
			<b>N/A</b>		
			<b>N/A</b>		
Total Cost:		\$ 1850.00			
			<b>Yes</b>	Surface Condition? (G/P)	Good
