Access Compliance Report

Public Rights-of-Way

(Curb Ramps)

Intersection ID: 10024552	Main Street: D_DUCKS_LN	Cross Street: N/A	Location: SE
ADA ID: DECEED0AB8ED	Ramp Type: PerpDiag	Initial Pass/Fail: Fail	Overall Compliance: No
Severity Score: 10			
Codes/Mitigation Info/Possible Solution		Field Measurements/Component Compliance

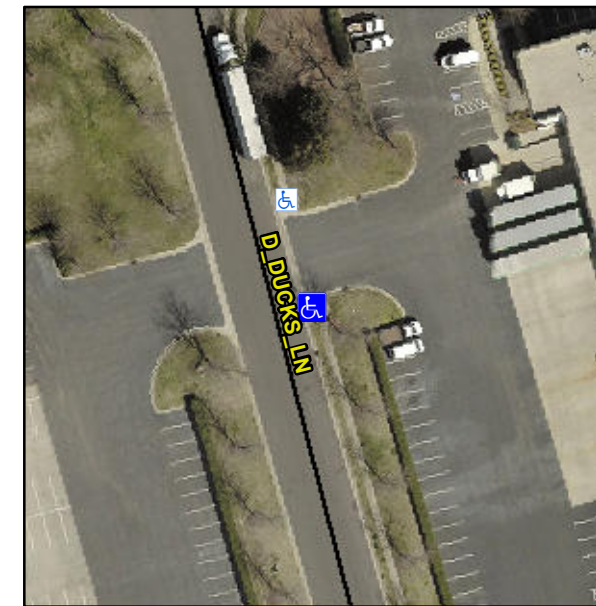
Not Found, R304.5.1, R304.5.3

Compliance	Description	Data	Compliance	Description	Data
N/A	Ramp Length (in)	38.0	Yes	Ramp Slope (%)	5.4
No	Ramp Width (in)	46.0	No	Ramp XSlope (%)	2.2
N/A	Flare Type LT	N/A	N/A	Flare Type RT	N/A
N/A	Flare Slope LT (%)	N/A	N/A	Flare Slope RT (%)	N/A
N/A	Flare Traversable LT?	N/A	N/A	Flare Traversable RT?	N/A
N/A	Landing Length (in)	N/A	N/A	DWS Provided?	N/A
N/A	Landing Width (in)	N/A	N/A	DWS Contrast?	N/A
N/A	Landing Slope (%)	N/A	N/A	DWS Length (in)	N/A
N/A	Landing X Slope (%)	N/A	N/A	DWS Full Width?	N/A
N/A	Landing Curb? (Y/N)	N/A	N/A	DWS Offset (in)	N/A
N/A	Shared Landing?	N/A			
N/A	Gutter Ponding?	N/A	N/A	Gutter Slope (%)	N/A
N/A	Gutter Lip Ht (in)	N/A	N/A	Gutter X Slope (%)	N/A
N/A	Painted X Walk1?	No	N/A	Painted X Walk2?	No
	X Walk 1 Direction	To N		X Walk 2 Direction	To W
N/A	X Walk 1 Width (in)	N/A	N/A	X Walk 2 Width (in)	N/A
	X Walk 1 Slope (%)	1.8		X Walk 2 Slope (%)	4.4
	X Walk 1 X Slope (%)	2.1		X Walk 2 X Slope (%)	1.6

N/A	Ramp inside XWalk1?	N/A	N/A	Ramp inside XWalk2?	N/A
	Road Slope (%)	3.0	N/A	Clear Space?	N/A
	Road X Slope (%)	8.4	N/A	Clear Space to XWalk (in)	N/A
N/A	Any Obstructions?	N/A	N/A	Storm Grate/Utility Hazard?	N/A
	Obstruction Type			Storm Grate/Utility Type	
		N/A			N/A
			Yes	Surface Condition? (G/P)	Good

Possible Solutions:

Remove & Replace Curb Ramp With Two New Directional Ramps or Equivalent.

Total Cost: \$ 3200.00
