Access Compliance Report

Public Rights-of-Way

(Curb Ramps)

Intersection ID: 18328	Main Street: COATBRIDGE_LN	Cross Street: MCLAUGHLIN_DR	Location: NE
ADA ID: DED84D2D7FEA	Ramp Type: Directional1	Initial Pass/Fail: Fail	Overall Compliance: No
Severity Score: 8.75			
Codes/Mitigation Info/Possible Solution		Field Measurements/Component Compliance

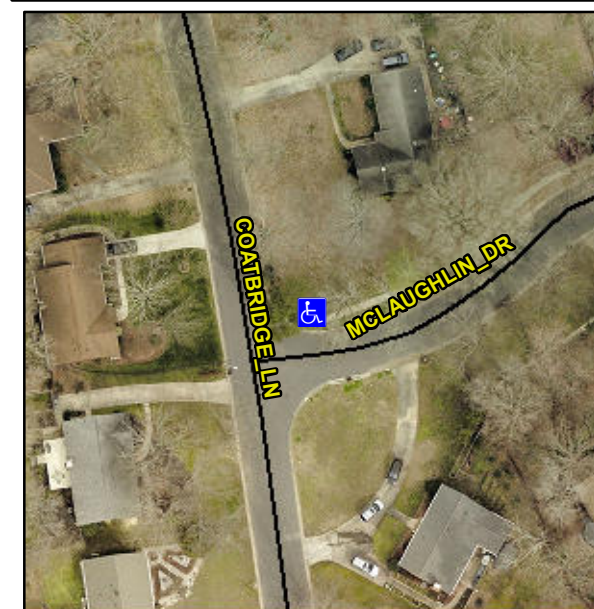
Compliance	Description	Data	Compliance	Description	Data
N/A	Ramp Length (in)	66.0	N/A	Grade Break?	N/A
No	Ramp Width (in)	47.0	N/A	Grade Break Slope (%)	0.0
Yes	Ramp Slope (%)	1.1	N/A	Grade Break XSlope (%)	0.0
Yes	Ramp XSlope (%)	1.8			
N/A	Flare Type LT	N/A	N/A	Flare Type RT	N/A
N/A	Flare Slope LT (%)	N/A	N/A	Flare Slope RT (%)	0.0
N/A	Flare Traversable LT?	N/A	N/A	Flare Traversable RT?	N/A
N/A	Landing Length (in)	0.0	N/A	DWS Provided?	N/A
N/A	Landing Width (in)	0.0	N/A	DWS Contrast?	N/A
N/A	Landing Slope (%)	0.0	N/A	DWS Length (in)	N/A
N/A	Landing X Slope (%)	0.0	N/A	DWS Full Width?	N/A
N/A	Landing Curb? (Y/N)	N/A	N/A	DWS Offset LT (in)	N/A
N/A	Shared Landing?	N/A	N/A	DWS Offset RT (in)	N/A
N/A	Gutter Ponding?	0.0	N/A	Gutter Slope (%)	N/A
N/A	Gutter Lip Ht (in)	0.0	N/A	Gutter X Slope (%)	N/A
N/A	Painted X Walk1?	No		Road Slope (%)	3.8
	X Walk 1 Direction	To SW		Road X Slope (%)	1.3
	X Walk 1 Width (in)	N/A		Clear Space?	N/A

X Walk 1 Slope (%)	3.8	N/A	Clear Space to XWalk (in)	N/A
	X Walk 1 X Slope (%)	1.3	N/A	Storm Grate/Utility Hazard?	N/A
N/A	Ramp inside XWalk1?	N/A		Storm Grate/Utility Type	
N/A	Any Obstructions?	N/A			N/A
	Obstruction Type		Yes	Surface Condition? (G/P)	Good
			N/A	Curb Slope (%)	4.6

Possible Solutions:

Remove & Replace Entire Ramp.

R304.5.1
