Access Compliance Report

Public Rights-of-Way

(Curb Ramps)

Intersection ID: 44333	Main Street: BROWNE_RD	Cross Street: RETRIEVER_WY	Location: SE
ADA ID: DED9F6912E3D	Ramp Type: Perp	Initial Pass/Fail: Fail	Overall Compliance: No
Severity Score: 12.5			
Codes/Mitigation Info/Possible Solution		Field Measurements/Component Compliance

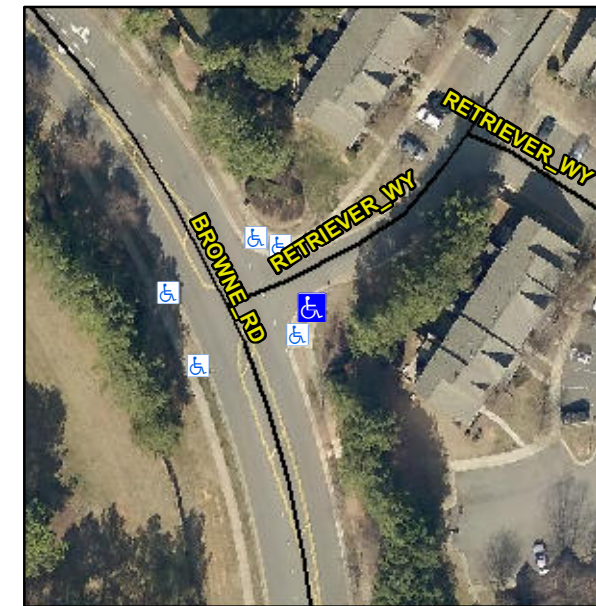
Compliance	Description	Data	Compliance	Description	Data
N/A	Ramp Length (in)	63.5	No	Ramp Slope (%)	11.7
Yes	Ramp Width (in)	48.0	Yes	Ramp XSlope (%)	2.0
N/A	Flare Type LT	N/A	N/A	Flare Type RT	N/A
N/A	Flare Slope LT (%)	N/A	N/A	Flare Slope RT (%)	N/A
N/A	Flare Traversable LT?	N/A	N/A	Flare Traversable RT?	N/A
N/A	Landing Length (in)	N/A	N/A	DWS Provided?	N/A
N/A	Landing Width (in)	N/A	N/A	DWS Contrast?	N/A
N/A	Landing Slope (%)	N/A	N/A	DWS Length (in)	N/A
N/A	Landing X Slope (%)	N/A	N/A	DWS Full Width?	N/A
N/A	Landing Curb? (Y/N)	N/A	N/A	DWS Offset (in)	N/A
N/A	Shared Landing?	N/A			
N/A	Gutter Ponding?	N/A	N/A	Gutter Slope (%)	N/A
N/A	Gutter Lip Ht (in)	N/A	N/A	Gutter X Slope (%)	N/A
N/A	Painted X Walk1?	No	N/A	Painted X Walk2?	N/A
	X Walk 1 Direction	To N		X Walk 2 Direction	N/A
N/A	X Walk 1 Width (in)	N/A	N/A	X Walk 2 Width (in)	N/A
	X Walk 1 Slope (%)	3.2		X Walk 2 Slope (%)	N/A
	X Walk 1 X Slope (%)	3.1		X Walk 2 X Slope (%)	N/A

Possible Solutions:

Remove & Replace Entire Ramp.

R304.2.2
