Access Compliance Report

Public Rights-of-Way

(Curb Ramps)

Intersection ID: 3494	Main Street: REAMES_RD	Cross Street: W_W_T_HARRIS_BV	Location: SE
ADA ID: DEE1BFC594B0	Ramp Type: Perp	Initial Pass/Fail: Fail	Overall Compliance: No
Severity Score: 30			
Codes/Mitigation Info/Possible Solution		Field Measurements/Component Compliance

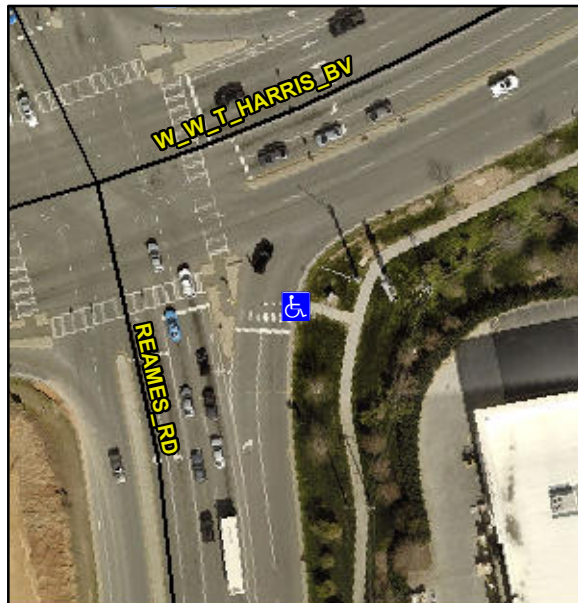
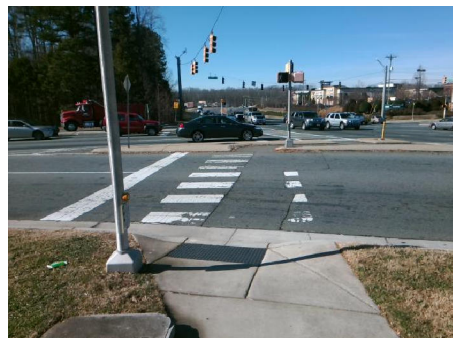
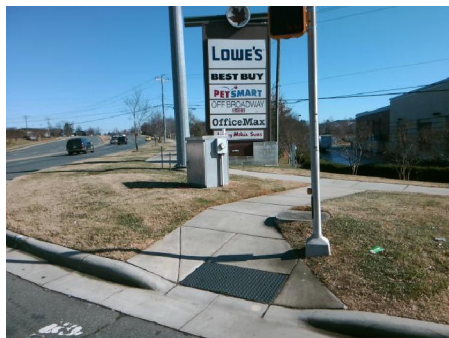
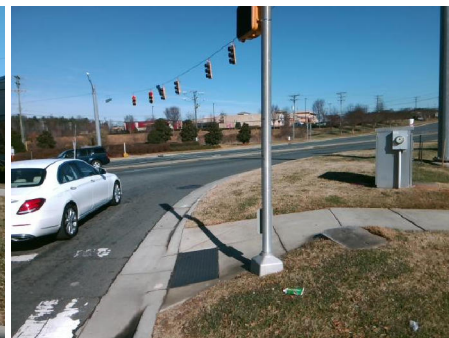
Not Found, R304.5.1, R304.2.2

Compliance	Description	Data	Compliance	Description	Data
N/A	Ramp Length (in)	63.0	No	Ramp Slope (%)	11.4
No	Ramp Width (in)	35.0	Yes	Ramp XSlope (%)	1.0
N/A	Flare Type LT	N/A	N/A	Flare Type RT	N/A
N/A	Flare Slope LT (%)	N/A	N/A	Flare Slope RT (%)	N/A
N/A	Flare Traversable LT?	N/A	N/A	Flare Traversable RT?	N/A
N/A	Landing Length (in)	N/A	N/A	DWS Provided?	N/A
N/A	Landing Width (in)	N/A	N/A	DWS Contrast?	N/A
N/A	Landing Slope (%)	N/A	N/A	DWS Length (in)	N/A
N/A	Landing X Slope (%)	N/A	N/A	DWS Full Width?	N/A
N/A	Landing Curb? (Y/N)	N/A	N/A	DWS Offset (in)	N/A
N/A	Shared Landing?	N/A			
N/A	Gutter Ponding?	N/A	N/A	Gutter Slope (%)	N/A
N/A	Gutter Lip Ht (in)	N/A	N/A	Gutter X Slope (%)	N/A
N/A	Painted X Walk1?	Yes	N/A	Painted X Walk2?	N/A
	X Walk 1 Direction	To NW		X Walk 2 Direction	N/A
N/A	X Walk 1 Width (in)	117.0	N/A	X Walk 2 Width (in)	N/A
	X Walk 1 Slope (%)	2.0		X Walk 2 Slope (%)	N/A
	X Walk 1 X Slope (%)	2.1		X Walk 2 X Slope (%)	N/A

N/A	Ramp inside XWalk1?	Yes	N/A	Ramp inside XWalk2?	N/A
	Road Slope (%)	N/A	N/A	Clear Space?	N/A
	Road X Slope (%)	N/A	N/A	Clear Space to XWalk (in)	N/A
N/A	Any Obstructions?	N/A	N/A	Storm Grate/Utility Hazard?	N/A
	Obstruction Type			Storm Grate/Utility Type	
		N/A			N/A
			Yes	Surface Condition? (G/P)	Good

Possible Solutions:

Remove & Replace Entire Ramp.
