# Access Compliance Report

## Public Rights-of-Way

Intersection ID: 45689	Main Street: ALOYSIA_LN	Cross Street: CANIPE_FARM_CT	Location: NW
ADA ID: DEEB5EA3D7B9	Ramp Type: PerpDiag	Initial Pass/Fail: Fail	Overall Compliance: No
Severity Score: 10			
Codes/Mitigation Info/Possible Solution		Field Measurements/Component Compliance

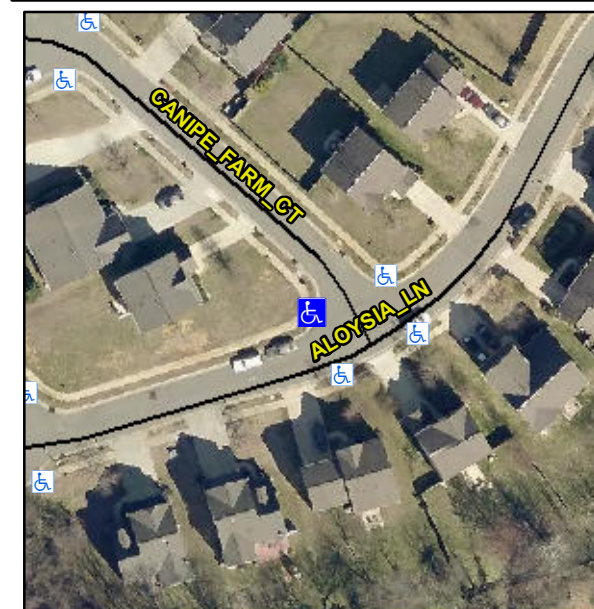
**Not Found, R304.5.1, R304.5.3**

Compliance	Description	Data	Compliance	Description	Data
N/A	Ramp Length (in)	46.5	Yes	Ramp Slope (%)	6.0
No	Ramp Width (in)	41.0	No	Ramp XSlope (%)	4.5
N/A	Flare Type LT	N/A	N/A	Flare Type RT	N/A
N/A	Flare Slope LT (%)	N/A	N/A	Flare Slope RT (%)	N/A
N/A	Flare Traversable LT?	N/A	N/A	Flare Traversable RT?	N/A
N/A	Landing Length (in)	N/A	N/A	DWS Provided?	N/A
N/A	Landing Width (in)	N/A	N/A	DWS Contrast?	N/A
N/A	Landing Slope (%)	N/A	N/A	DWS Length (in)	N/A
N/A	Landing X Slope (%)	N/A	N/A	DWS Full Width?	N/A
N/A	Landing Curb? (Y/N)	N/A	N/A	DWS Offset (in)	N/A
N/A	Shared Landing?	N/A			
N/A	Gutter Ponding?	N/A	N/A	Gutter Slope (%)	N/A
N/A	Gutter Lip Ht (in)	N/A	N/A	Gutter X Slope (%)	N/A
N/A	Painted X Walk1?	No	N/A	Painted X Walk2?	No
	X Walk 1 Direction	To S		X Walk 2 Direction	To E
N/A	X Walk 1 Width (in)	N/A	N/A	X Walk 2 Width (in)	N/A
	X Walk 1 Slope (%)	0.1		X Walk 2 Slope (%)	3.6
	X Walk 1 X Slope (%)	3.0		X Walk 2 X Slope (%)	2.1

N/A	Ramp inside XWalk1?	N/A	N/A	Ramp inside XWalk2?	N/A
	Road Slope (%)	2.6	N/A	Clear Space?	N/A
	Road X Slope (%)	1.3	N/A	Clear Space to XWalk (in)	N/A
N/A	Any Obstructions?	N/A	N/A	Storm Grate/Utility Hazard?	N/A
	Obstruction Type			Storm Grate/Utility Type	
		N/A			N/A
		Yes		Surface Condition? (G/P)	Good

**Remove & Replace Curb Ramp With Two New Directional Ramps or Equivalent.**
