| Intersection ID: 10037292 | Main Street: SARDIS_RD | Cross Street: N/A | Location: | W |
| ADA ID: DEF52B25B780 | Ramp Type: MedianPerp | Initial Pass/Fail: Fail | Overall Compliance: No | Severity Score: 26.25 |

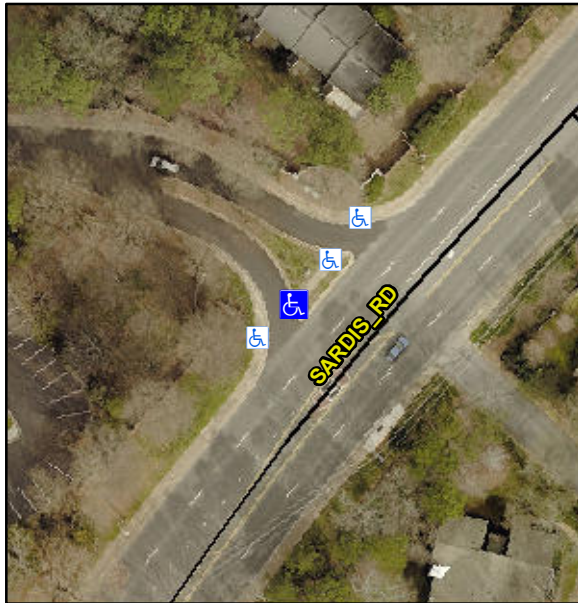
**Not Found, R304.2.2, R304.5.3**

| Compliance | Description | Data | Compliance | Description | Data |
|---|---|---|---|---|---|
| N/A | Ramp Length (in) | 64.0 | No | Ramp Slope (%) | 12.1 |
| Yes | Ramp Width (in) | 48.0 | No | Ramp XSlope (%) | 3.8 |

### Possible Solutions:

### Remove & Replace Entire Ramp.
