Access Compliance Report Public Rights-of-Way (Curb Ramps)

Intersection ID: 42838Main Street:SARDIS_OAKS_RDCross Street:SARDIS_RD_NORTHLocation:SWADA ID: DEF703D959A0Ramp Type:ParaInitial Pass/Fail:FailOverall Compliance:NoSeverity Score:13.75

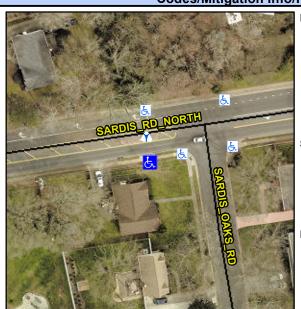
Field Measurements/Component Compliance						
	liance Description	Data		liance Description	Data	
N/A	Ramp Length LT (in)	72.0	N/A	Ramp Length RT (in)	72.0	
Yes	Ramp Width LT (in)	64.0	Yes	Ramp Width RT (in)	64.0	
No	Ramp Slope LT (%)	8.8	Yes	Ramp Slope RT (%)	5.5	
Yes	Ramp XSlope LT (%)	0.0	No	Ramp XSlope RT (%)	2.2	
N/A	Landing Length (in)	N/A	N/A	DWS Provided?	N/A	
N/A	Landing Width (in)	N/A	N/A	DWS Contrast?	N/A	
N/A	Landing Slope (%)	N/A	N/A	DWS Length (in)	N/A	
N/A	Landing X Slope (%)	N/A	N/A	DWS Full Width?	N/A	
N/A	Landing Curb? (Y/N)	N/A	N/A	DWS Offset (in)	N/A	
N/A	Shared Landing?	N/A				
N/A	Gutter Ponding?	N/A	N/A	Gutter Slope (%)	N/A	
N/A	Gutter Lip Ht (in)	N/A	N/A	Gutter X Slope (%)	N/A	
N/A	Painted X Walk1?	No	N/A	Painted X Walk2?	N/A	
	X Walk 1 Direction	To N		X Walk 2 Direction	N/A	
N/A	X Walk 1 Width (in)	N/A	N/A	X Walk 2 Width (in)	N/A	
	X Walk 1 Slope (%)	4.0		X Walk 2 Slope (%)	N/A	
	X Walk 1 X Slope (%)	0.8		X Walk 2 X Slope (%)	N/A

N/A	Ramp inside XWalk1?	N/A	N/A	Ramp inside XWalk2?	N/A	
	Road Slope (%)	N/A	N/A	Clear Space?	N/A	
	Road X Slope (%)	N/A	N/A	Clear Space to XWalk (in)	N/A	
N/A	Any Obstructions?	N/A	N/A	Storm Grate/Utility Hazard?	N/A	
	Obstruction Type			Storm Grate/Utility Type		
		N/A			N/A	
			Yes	Surface Condition? (G/P)	Good	
			N/A	Curb Slope (%)	12.1	
Was.

OSSIBLE SOLUTION	
Possible Solutions:	
Remove & Replace Entire Ramp.	
	,
	,
	I
	I
Surveyor Notes:	
N/A	ı
	I
PROW/ADA:	
R304.3.2, R304.5.3

Total Cost: \$ 1600.00
