# Access Compliance Report

## Public Rights-of-Way

### (Curb Ramps)

| ADA ID: DEFA341A6875 | Ramp Type: PerpDiag | Initial Pass/Fail: Fail | Overall Compliance: No |

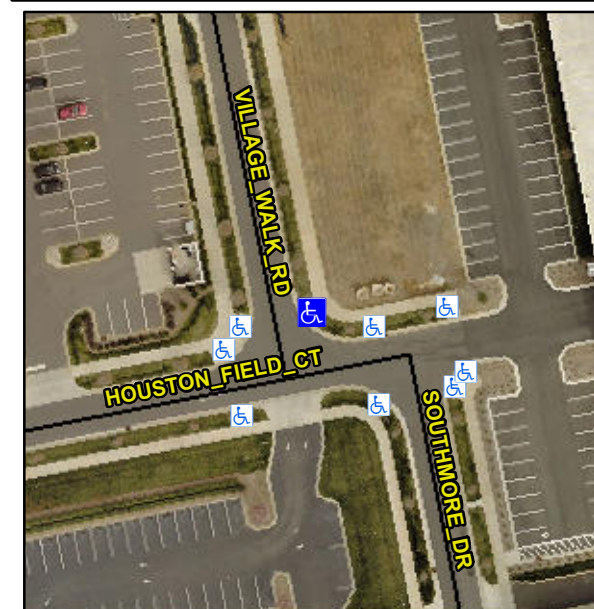
**Not Found, R304.2.2, R304.5.3**

| Compliance | Description | Data | Compliance | Description | Data |
|---|---|---|---|---|---|
| N/A | Ramp Length (in) | 94.0 | No | Ramp Slope (%) | 8.8 |
| Yes | Ramp Width (in) | 48.0 | No | Ramp XSlope (%) | 3.2 |

**Remove & Replace Curb Ramp With Two New Directional Ramps or Equivalent.**
