Access Compliance Report

Public Rights-of-Way

(Curb Ramps)

Intersection ID: 50937	Main Street: CANMORE_ST	Cross Street: HAWFIELD_WAY_DR	Location: NE
ADA ID: DEFBC982220E	Ramp Type: PerpDiag	Initial Pass/Fail: Fail	Overall Compliance: No
Severity Score: 10			
Codes/Mitigation Info/Possible Solution		Field Measurements/Component Compliance

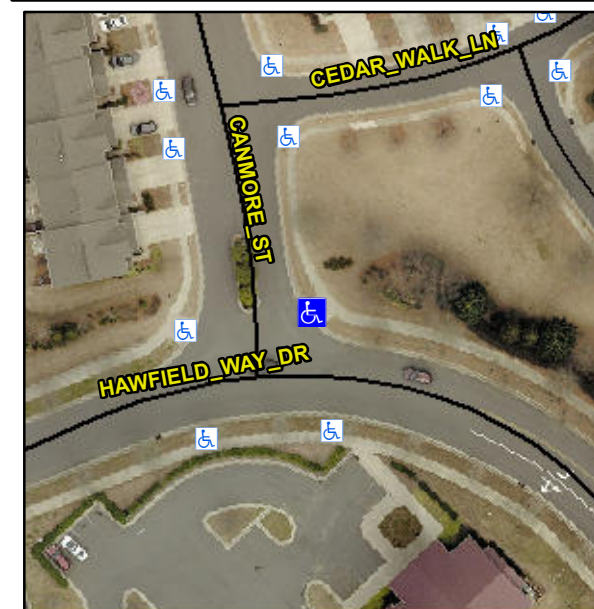
Not Found, R304.5.1, R304.5.3

Compliance	Description	Data	Compliance	Description	Data
N/A	Ramp Length (in)	97.0	Yes	Ramp Slope (%)	6.7
No	Ramp Width (in)	47.0	No	Ramp XSlope (%)	4.1
N/A	Flare Type LT	N/A	N/A	Flare Type RT	N/A
N/A	Flare Slope LT (%)	N/A	N/A	Flare Slope RT (%)	N/A
N/A	Flare Traversable LT?	N/A	N/A	Flare Traversable RT?	N/A
N/A	Landing Length (in)	N/A	N/A	DWS Provided?	N/A
N/A	Landing Width (in)	N/A	N/A	DWS Contrast?	N/A
N/A	Landing Slope (%)	N/A	N/A	DWS Length (in)	N/A
N/A	Landing X Slope (%)	N/A	N/A	DWS Full Width?	N/A
N/A	Landing Curb? (Y/N)	N/A	N/A	DWS Offset (in)	N/A
N/A	Shared Landing?	N/A			
N/A	Gutter Ponding?	N/A	N/A	Gutter Slope (%)	N/A
N/A	Gutter Lip Ht (in)	N/A	N/A	Gutter X Slope (%)	N/A
N/A	Painted X Walk1?	No	N/A	Painted X Walk2?	No
	X Walk 1 Direction	To W		X Walk 2 Direction	To S
N/A	X Walk 1 Width (in)	N/A	N/A	X Walk 2 Width (in)	N/A
	X Walk 1 Slope (%)	0.8		X Walk 2 Slope (%)	2.8
	X Walk 1 X Slope (%)	4.8		X Walk 2 X Slope (%)	1.3

N/A	Ramp inside XWalk1?	N/A	N/A	Ramp inside XWalk2?	N/A
	Road Slope (%)	3.6	N/A	Clear Space?	N/A
	Road X Slope (%)	4.1	N/A	Clear Space to XWalk (in)	N/A
N/A	Any Obstructions?	N/A	N/A	Storm Grate/Utility Hazard?	N/A
	Obstruction Type			Storm Grate/Utility Type	
		N/A			N/A
			Yes	Surface Condition? (G/P)	Good

Remove & Replace Curb Ramp With Two New Directional Ramps or Equivalent.
