Access Compliance Report

Public Rights-of-Way

(Curb Ramps)

Intersection ID: 51491	Main Street: N_TRYON_ST	Cross Street: INSTITUTE_CR	Location: W
ADA ID: DF0B6F22E41C	Ramp Type: Perp	Initial Pass/Fail: Fail	Overall Compliance: No
		Severity Score: 1.25

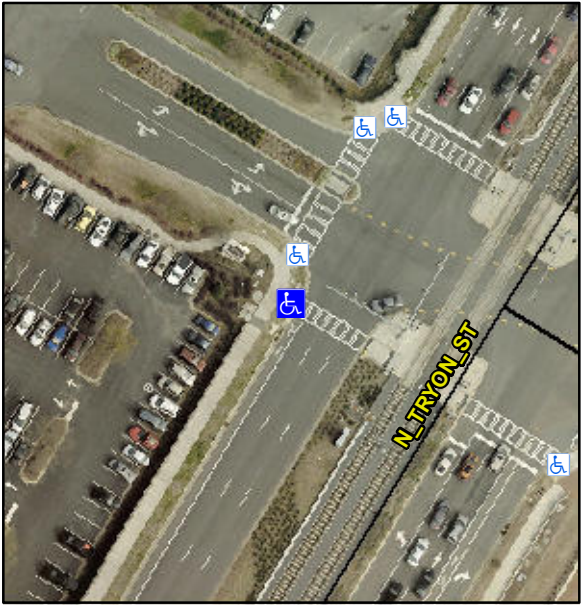
Possible Solutions:		Compliance	Description	Data
	Remove & Replace Entire Ramp.		Yes	Ramp Length (in)	96.0
			N/A	Ramp Width (in)	65.0
			N/A	Flare Type LT	N/A
			N/A	Flare Slope LT (%)	N/A
			N/A	Flare Traversable LT?	N/A
			N/A	Flare Traversable RT?	N/A
			N/A	DWS Provided?	N/A
			N/A	DWS Contrast?	N/A
			N/A	DWS Length (in)	N/A
<p>Surveyor Notes:</p> <p>N/A</p> <p>PROW/ADA:</p> <p>Not Found, R304.5.3</p>			N/A	DWS Full Width?	N/A
			N/A	DWS Offset (in)	N/A
			N/A	Shared Landing?	N/A
			N/A	Gutter Ponding?	N/A
			N/A	Gutter Lip Ht (in)	1.5
			N/A	Painted X Walk1?	No
			N/A	X Walk 1 Direction	To SE
			N/A	X Walk 1 Width (in)	N/A
			N/A	X Walk 1 Slope (%)	1.9
			N/A	X Walk 1 X Slope (%)	3.9
<p>Total Cost: \$ 1850.00</p>			N/A	X Walk 2 Direction	N/A
			N/A	X Walk 2 Width (in)	N/A
			N/A	X Walk 2 Slope (%)	N/A
			N/A	X Walk 2 X Slope (%)	N/A

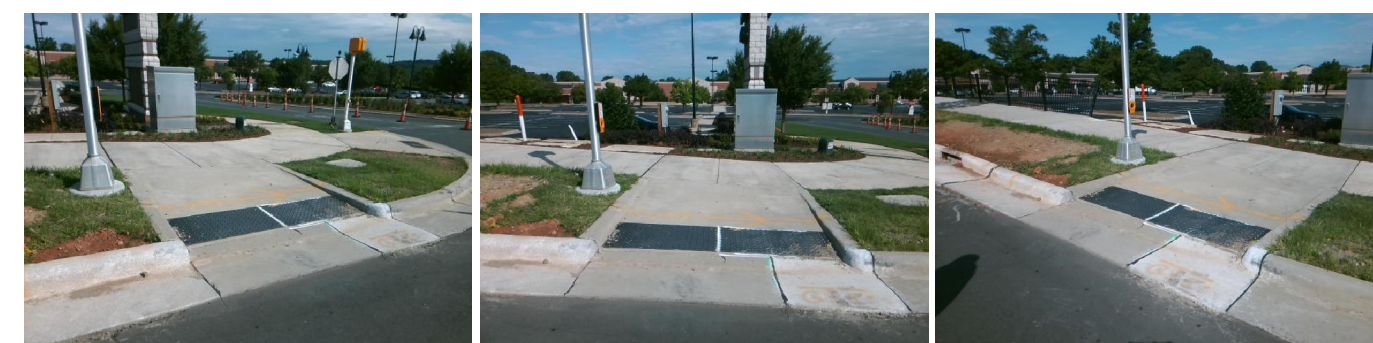
N/A	Ramp inside XWalk1?	N/A
			N/A	Ramp inside XWalk2?	N/A
			N/A	Clear Space?	N/A
			N/A	Clear Space to XWalk (in)	N/A
			N/A	Storm Grate/Utility Hazard?	N/A
			N/A	Storm Grate/Utility Type	N/A
<p>Street 1 Name N TRYON ST</p> <p>Stop Condition-Street 2 Signal</p> <p>Street 2 Name N/A</p> <p>Stop Condition-Street 1 N/A</p>			N/A	Surface Condition? (G/P)	Good
			N/A
