# Access Compliance Report

## Public Rights-of-Way

### (Curb Ramps)

| Intersection ID: N/A | Main Street: KENSAL_GREEN_DR | Cross Street: WILTSHIRE_MANOR_DR | Location: SE |

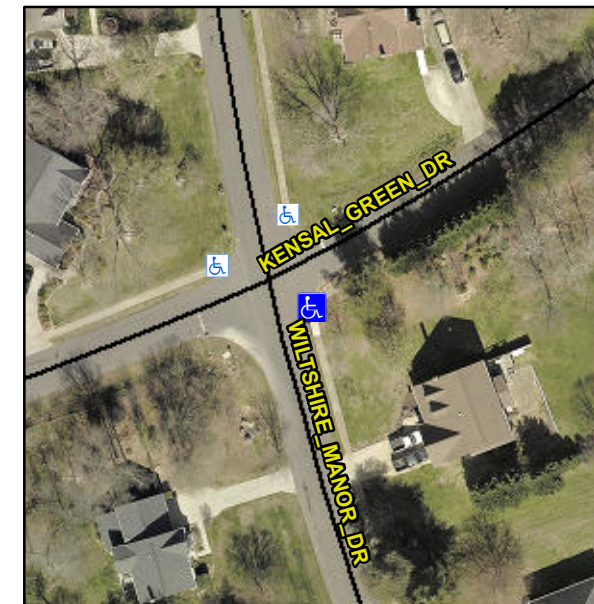
**NO CURB**

| Compliance | Description | Data | Compliance | Description | Data |
|---|---|---|---|---|---|
| N/A | Landing Length (in) | N/A | No | DWS Provided? | No |
| Yes | Gutter Ponding? | No | No | Gutter Slope (%) | 5.1 |

**Install Detectable Warning System.  
Remove & Replace Gutter.**

**R305, R304.5.4**

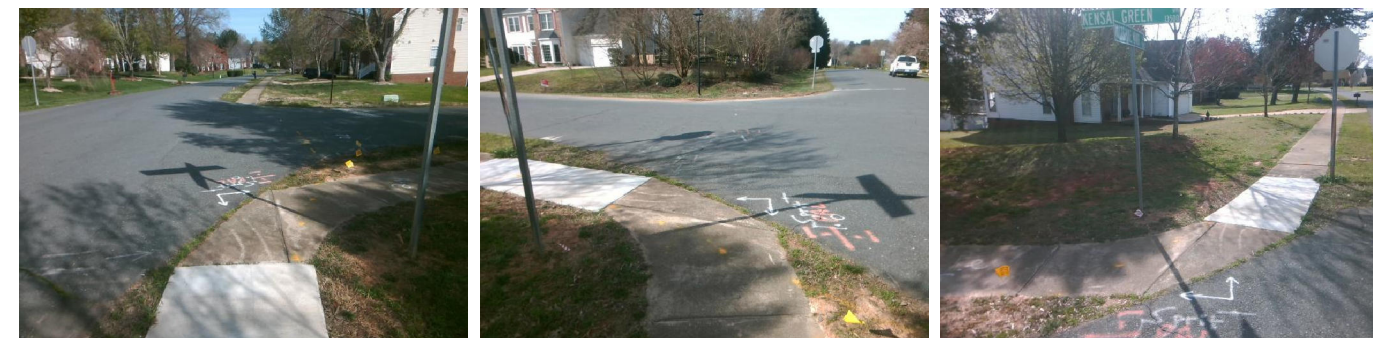
| Compliance | Description | Data | Compliance | Description | Data |
|---|---|---|---|---|---|
| N/A | Landing X Slope (%) | N/A | N/A | DWS Full Width? | No |

Possible Solutions:
