# Access Compliance Report

## Public Rights-of-Way

### (Curb Ramps)

Intersection ID: 10026777	Main Street: FOREST_CROSS_DR	Cross Street: N/A	Location:	N
ADA ID: DF2929321DF9	Ramp Type: Perp	Initial Pass/Fail: Fail	Overall Compliance: No	Severity Score: 25
Codes/Mitigation Info/Possible Solution		Field Measurements/Component Compliance

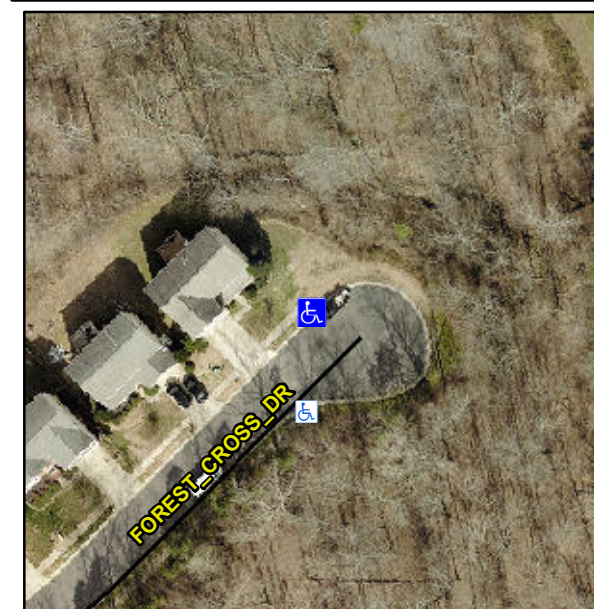
**Not Found, R304.2.2, R304.5.3**

Compliance	Description	Data	Compliance	Description	Data
N/A	Ramp Length (in)	48.0	No	Ramp Slope (%)	8.5
Yes	Ramp Width (in)	55.0	No	Ramp XSlope (%)	6.3
N/A	Flare Type LT	N/A	N/A	Flare Type RT	N/A
N/A	Flare Slope LT (%)	N/A	N/A	Flare Slope RT (%)	N/A
N/A	Flare Traversable LT?	N/A	N/A	Flare Traversable RT?	N/A
N/A	Landing Length (in)	N/A	N/A	DWS Provided?	N/A
N/A	Landing Width (in)	N/A	N/A	DWS Contrast?	N/A
N/A	Landing Slope (%)	N/A	N/A	DWS Length (in)	N/A
N/A	Landing X Slope (%)	N/A	N/A	DWS Full Width?	N/A
N/A	Landing Curb? (Y/N)	N/A	N/A	DWS Offset (in)	N/A
N/A	Shared Landing?	N/A			
N/A	Gutter Ponding?	N/A	N/A	Gutter Slope (%)	N/A
N/A	Gutter Lip Ht (in)	N/A	N/A	Gutter X Slope (%)	N/A
N/A	Painted X Walk1?	No	N/A	Painted X Walk2?	N/A
	X Walk 1 Direction	To S		X Walk 2 Direction	N/A
N/A	X Walk 1 Width (in)	N/A	N/A	X Walk 2 Width (in)	N/A
	X Walk 1 Slope (%)	2.8		X Walk 2 Slope (%)	N/A
	X Walk 1 X Slope (%)	1.7		X Walk 2 X Slope (%)	N/A

N/A	Ramp inside XWalk1?	N/A	N/A	Ramp inside XWalk2?	N/A
	Road Slope (%)	1.7	N/A	Clear Space?	N/A
	Road X Slope (%)	2.8	N/A	Clear Space to XWalk (in)	N/A
N/A	Any Obstructions?	N/A	N/A	Storm Grate/Utility Hazard?	N/A
	Obstruction Type			Storm Grate/Utility Type	
		N/A			N/A
			Yes	Surface Condition? (G/P)	Good

Possible Solutions:

**Remove & Replace Entire Ramp.**
