Access Compliance Report

Public Rights-of-Way

(Curb Ramps)

Intersection ID: 10748	Main Street: JOHNSON_ST	Cross Street: POLK_ST	Location: E
ADA ID: DF351817CECA	Ramp Type: Directional1	Initial Pass/Fail: Fail	Overall Compliance: No
Severity Score: 22.5			
Codes/Mitigation Info/Possible Solution		Field Measurements/Component Compliance

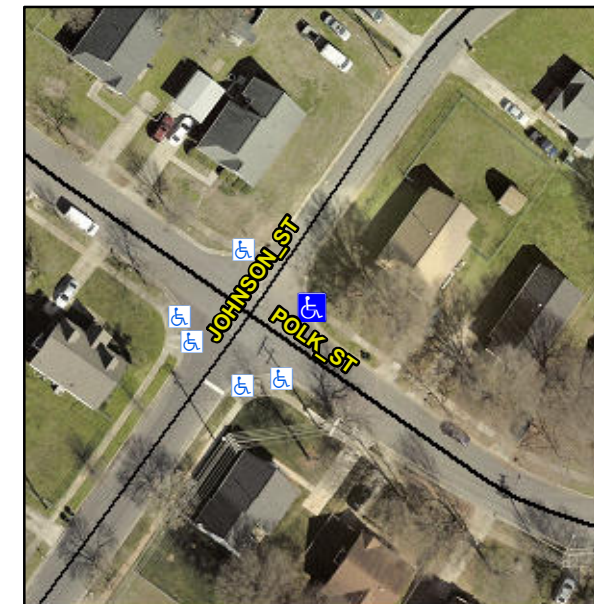
VEGETATION OVERGROWTH

R304.5.1, R304.2.2, R304.5.3

Compliance	Description	Data	Compliance	Description	Data
N/A	Ramp Length (in)	47.0	N/A	Grade Break?	N/A
No	Ramp Width (in)	46.5	N/A	Grade Break Slope (%)	0.0
No	Ramp Slope (%)	9.6	N/A	Grade Break XSlope (%)	0.0
No	Ramp XSlope (%)	3.5			
N/A	Flare Type LT	N/A	N/A	Flare Type RT	N/A
N/A	Flare Slope LT (%)	N/A	N/A	Flare Slope RT (%)	0.0
N/A	Flare Traversable LT?	N/A	N/A	Flare Traversable RT?	N/A
N/A	Landing Length (in)	0.0	N/A	DWS Provided?	N/A
N/A	Landing Width (in)	0.0	N/A	DWS Contrast?	N/A
N/A	Landing Slope (%)	0.0	N/A	DWS Length (in)	N/A
N/A	Landing X Slope (%)	0.0	N/A	DWS Full Width?	N/A
N/A	Landing Curb? (Y/N)	N/A	N/A	DWS Offset LT (in)	N/A
N/A	Shared Landing?	N/A	N/A	DWS Offset RT (in)	N/A
N/A	Gutter Ponding?	0.0	N/A	Gutter Slope (%)	N/A
N/A	Gutter Lip Ht (in)	0.5	N/A	Gutter X Slope (%)	N/A
N/A	Painted X Walk1?	No		Road Slope (%)	1.2
	X Walk 1 Direction	To NW		Road X Slope (%)	0.5
	X Walk 1 Width (in)	N/A		Clear Space?	N/A

X Walk 1 Slope (%)	1.2	N/A	Clear Space to XWalk (in)	N/A
	X Walk 1 X Slope (%)	0.5	N/A	Storm Grate/Utility Hazard?	N/A
N/A	Ramp inside XWalk1?	N/A		Storm Grate/Utility Type	
N/A	Any Obstructions?	N/A			N/A
	Obstruction Type		Yes	Surface Condition? (G/P)	Good
			N/A	Curb Slope (%)	18.3

Possible Solutions:

Remove & Replace Entire Ramp.

Total Cost: \$ 1600.00
