Access Compliance Report

Public Rights-of-Way (Curb Ramps)

Intersection ID: 7871	Main Street: AMBERLY_LN	Cross Street: SNOW_WHITE_LN	Location: NW
ADA ID: DF3D83A1A735	Ramp Type: Directional1	Initial Pass/Fail: Fail	Overall Compliance: No
			Severity Score: 21.25

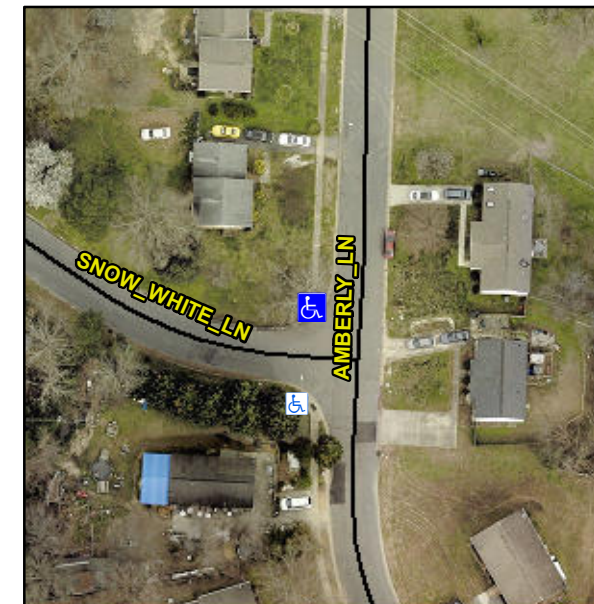
Compliance	Description	Data	Compliance	Description	Data
N/A	Ramp Length (in)	98.0	N/A	Grade Break?	N/A
No	Ramp Width (in)	40.0	N/A	Grade Break Slope (%)	0.0
No	Ramp Slope (%)	11.3	N/A	Grade Break XSlope (%)	0.0
Yes	Ramp XSlope (%)	2.0			
N/A	Flare Type LT	N/A	N/A	Flare Type RT	N/A
N/A	Flare Slope LT (%)	N/A	N/A	Flare Slope RT (%)	0.0
N/A	Flare Traversable LT?	N/A	N/A	Flare Traversable RT?	N/A
N/A	Landing Length (in)	0.0	N/A	DWS Provided?	N/A
N/A	Landing Width (in)	0.0	N/A	DWS Contrast?	N/A
N/A	Landing Slope (%)	0.0	N/A	DWS Length (in)	N/A
N/A	Landing X Slope (%)	0.0	N/A	DWS Full Width?	N/A
N/A	Landing Curb? (Y/N)	N/A	N/A	DWS Offset LT (in)	N/A
N/A	Shared Landing?	N/A	N/A	DWS Offset RT (in)	N/A
N/A	Gutter Ponding?	0.0	N/A	Gutter Slope (%)	N/A
N/A	Gutter Lip Ht (in)	0.0	N/A	Gutter X Slope (%)	N/A
N/A	Painted X Walk1?	No		Road Slope (%)	1.2
	X Walk 1 Direction	To S		Road X Slope (%)	4.2
	X Walk 1 Width (in)	N/A		Clear Space?	N/A

X Walk 1 Slope (%)	1.2	N/A	Clear Space to XWalk (in)	N/A
	X Walk 1 X Slope (%)	4.2	N/A	Storm Grate/Utility Hazard?	N/A
N/A	Ramp inside XWalk1?	N/A		Storm Grate/Utility Type	
N/A	Any Obstructions?	N/A			N/A
	Obstruction Type		Yes	Surface Condition? (G/P)	Good
			N/A	Curb Slope (%)	20.8

Remove & Replace Entire Ramp.
