# Access Compliance Report

## Public Rights-of-Way

### (Curb Ramps)

Intersection ID: 46200	Main Street: LOROPETALUM_RD	Cross Street: FERNSPRAY_RD	Location: S
ADA ID: DF419354BA55	Ramp Type: Perp	Initial Pass/Fail: Fail	Overall Compliance: No
Severity Score: 22.5			
Codes/Mitigation Info/Possible Solution		Field Measurements/Component Compliance

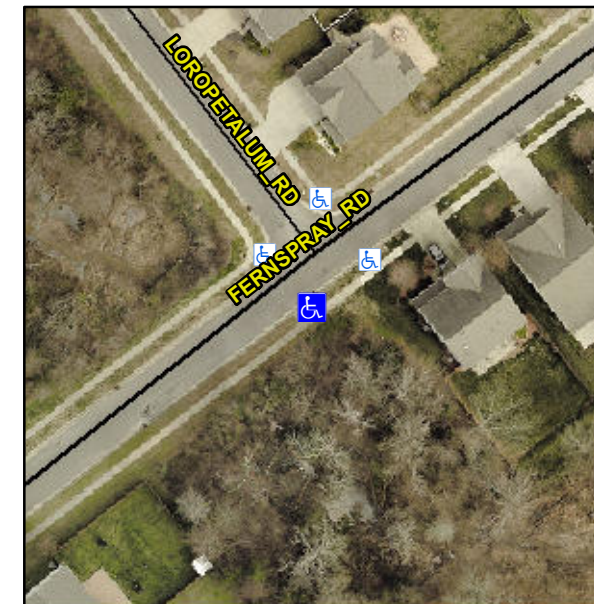
**Not Found, R304.5.1, R304.2.2**

Compliance	Description	Data	Compliance	Description	Data
N/A	Ramp Length (in)	70.5	No	Ramp Slope (%)	8.4
No	Ramp Width (in)	47.0	Yes	Ramp XSlope (%)	2.6
N/A	Flare Type LT	N/A	N/A	Flare Type RT	N/A
N/A	Flare Slope LT (%)	N/A	N/A	Flare Slope RT (%)	N/A
N/A	Flare Traversable LT?	N/A	N/A	Flare Traversable RT?	N/A
N/A	Landing Length (in)	N/A	N/A	DWS Provided?	N/A
N/A	Landing Width (in)	N/A	N/A	DWS Contrast?	N/A
N/A	Landing Slope (%)	N/A	N/A	DWS Length (in)	N/A
N/A	Landing X Slope (%)	N/A	N/A	DWS Full Width?	N/A
N/A	Landing Curb? (Y/N)	N/A	N/A	DWS Offset (in)	N/A
N/A	Shared Landing?	N/A			
N/A	Gutter Ponding?	N/A	N/A	Gutter Slope (%)	N/A
N/A	Gutter Lip Ht (in)	1.5	N/A	Gutter X Slope (%)	N/A
N/A	Painted X Walk1?	No	N/A	Painted X Walk2?	N/A
	X Walk 1 Direction	To NW		X Walk 2 Direction	N/A
N/A	X Walk 1 Width (in)	N/A	N/A	X Walk 2 Width (in)	N/A
	X Walk 1 Slope (%)	2.3		X Walk 2 Slope (%)	N/A
	X Walk 1 X Slope (%)	2.7		X Walk 2 X Slope (%)	N/A

N/A	Ramp inside XWalk1?	N/A	N/A	Ramp inside XWalk2?	N/A
	Road Slope (%)	N/A	N/A	Clear Space?	N/A
	Road X Slope (%)	N/A	N/A	Clear Space to XWalk (in)	N/A
N/A	Any Obstructions?	N/A	N/A	Storm Grate/Utility Hazard?	N/A
	Obstruction Type			Storm Grate/Utility Type	
		N/A			N/A
			Yes	Surface Condition? (G/P)	Good

**Remove & Replace Entire Ramp.**
