# Access Compliance Report

## Public Rights-of-Way

### (Curb Ramps)

Intersection ID: 14556	Main Street: E_WORTHINGTON_AV	Cross Street: WINTHROP_AV	Location:	N
ADA ID: DF4340871770	Ramp Type: Perp	Initial Pass/Fail: Fail	Overall Compliance: No	Severity Score: 1.25
Codes/Mitigation Info/Possible Solution		Field Measurements/Component Compliance

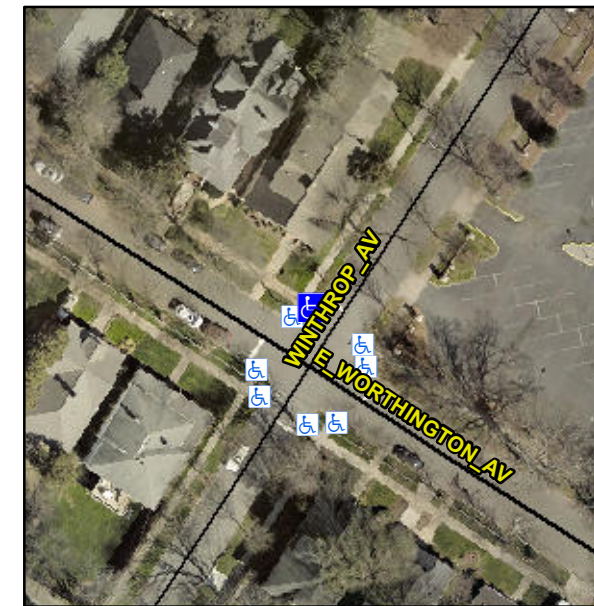
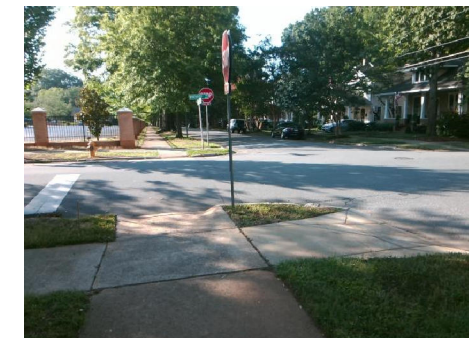
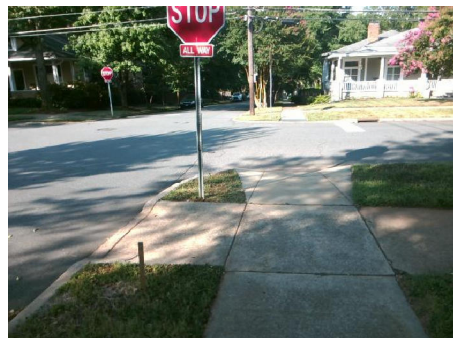
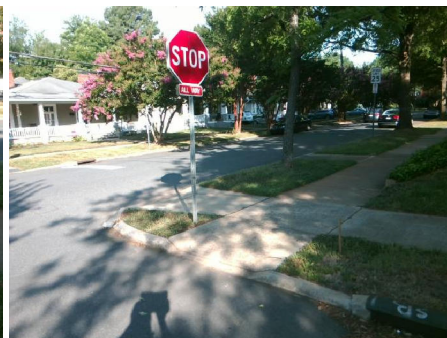
Compliance	Description	Data	Compliance	Description	Data
N/A	Ramp Length (in)	53.0	Yes	Ramp Slope (%)	6.5
Yes	Ramp Width (in)	48.0	No	Ramp XSlope (%)	5.0
N/A	Flare Type LT	N/A	N/A	Flare Type RT	N/A
N/A	Flare Slope LT (%)	N/A	N/A	Flare Slope RT (%)	N/A
N/A	Flare Traversable LT?	N/A	N/A	Flare Traversable RT?	N/A
N/A	Landing Length (in)	N/A	N/A	DWS Provided?	N/A
N/A	Landing Width (in)	N/A	N/A	DWS Contrast?	N/A
N/A	Landing Slope (%)	N/A	N/A	DWS Length (in)	N/A
N/A	Landing X Slope (%)	N/A	N/A	DWS Full Width?	N/A
N/A	Landing Curb? (Y/N)	N/A	N/A	DWS Offset (in)	N/A
N/A	Shared Landing?	N/A			
N/A	Gutter Ponding?	N/A	N/A	Gutter Slope (%)	N/A
N/A	Gutter Lip Ht (in)	N/A	N/A	Gutter X Slope (%)	N/A
N/A	Painted X Walk1?	No	N/A	Painted X Walk2?	N/A
	X Walk 1 Direction	To SE		X Walk 2 Direction	N/A
N/A	X Walk 1 Width (in)	N/A	N/A	X Walk 2 Width (in)	N/A
	X Walk 1 Slope (%)	5.5		X Walk 2 Slope (%)	N/A
	X Walk 1 X Slope (%)	1.0		X Walk 2 X Slope (%)	N/A

N/A	Ramp inside XWalk1?	N/A	N/A	Ramp inside XWalk2?	N/A
	Road Slope (%)	N/A	N/A	Clear Space?	N/A
	Road X Slope (%)	N/A	N/A	Clear Space to XWalk (in)	N/A
N/A	Any Obstructions?	N/A	N/A	Storm Grate/Utility Hazard?	N/A
	Obstruction Type			Storm Grate/Utility Type	
		N/A			N/A
		Yes		Surface Condition? (G/P)	Good

Possible Solutions:

**Remove & Replace Entire Ramp.**

**R304.5.3**

**\$ 1850.00**
