Access Compliance Report Public Rights-of-Way (Curb Ramps)

Main Street: PAT_GARRETT_ST Intersection ID: 52453 Cross Street: DOUBLE_OAKS_RD Location: NE **Overall Compliance: No Severity Score:** ADA ID: DF43AEB24A18 Ramp Type: Directional1 Initial Pass/Fail: Fail 12.5

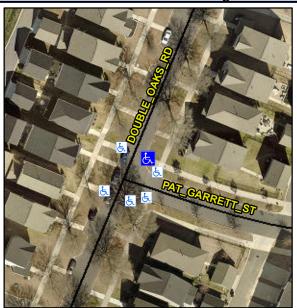
14/
			N/
PROW/ADA:			N/
R304.2.2			N/
			N/
			N/
Total Cost:	\$;	1600.00

Field Measurements/Component Compliance								
Comp	liance Description	Data	Comp	liance Description	Data			
N/A	Ramp Length (in)	83.0	N/A	Grade Break?	N/A			
Yes	Ramp Width (in)	60.0	N/A	Grade Break Slope (%)	0.0			
No	Ramp Slope (%)	9.7	N/A	Grade Break XSlope (%)	0.0			
Yes	Ramp XSlope (%)	1.2						
N/A	Flare Type LT	N/A	N/A	Flare Type RT	N/A			
N/A	Flare Slope LT (%)	N/A	N/A	Flare Slope RT (%)	0.0			
N/A	Flare Traversable LT?	N/A	N/A	Flare Traversable RT?	N/A			
N/A	Landing Length (in)	0.0	N/A	DWS Provided?	N/A			
N/A	Landing Width (in)	0.0	N/A	DWS Contrast?	N/A			
N/A	Landing Slope (%)	0.0	N/A	DWS Length (in)	N/A			
N/A	Landing X Slope (%)	0.0	N/A	DWS Full Width?	N/A			
N/A	Landing Curb? (Y/N)	N/A	N/A	DWS Offset LT (in)	N/A			
N/A	Shared Landing?	N/A	N/A	DWS Offset RT (in)	N/A			
N/A	Gutter Ponding?	0.0	N/A	Gutter Slope (%)	N/A			
N/A	Gutter Lip Ht (in)	2.0	N/A	Gutter X Slope (%)	N/A			
N/A	Painted X Walk1?	No		Road Slope (%)	2.9

X Walk 1 Direction	To W		Road X Slope (%)	0.2			
	X Walk 1 Width (in)	N/A	l	Clear Space?	N/A			
	X Walk 1 Slope (%)	2.9	N/A	Clear Space to XWalk (in)	N/A			
	X Walk 1 X Slope (%)	0.2	N/A	Storm Grate/Utility Hazard?	N/A			
N/A	Ramp inside XWalk1?	N/A		Storm Grate/Utility Type				
N/A	Any Obstructions?	N/A			N/A			
	Obstruction Type		Yes	Surface Condition? (G/P)	Good			
		N/A	N/A	Curb Slope (%)	12.2

Possible Solutions: Remove & Replace Entire Ramp. Surveyor Notes: N/A
