# Access Compliance Report

## Public Rights-of-Way

### (Curb Ramps)

Intersection ID: 44490	Main Street: CHALKSTONE_RD	Cross Street: DARWICK_ST	Location: NE
ADA ID: DF496390819F	Ramp Type: PerpDiag	Initial Pass/Fail: Fail	Overall Compliance: No
Severity Score: 10			
Codes/Mitigation Info/Possible Solution		Field Measurements/Component Compliance

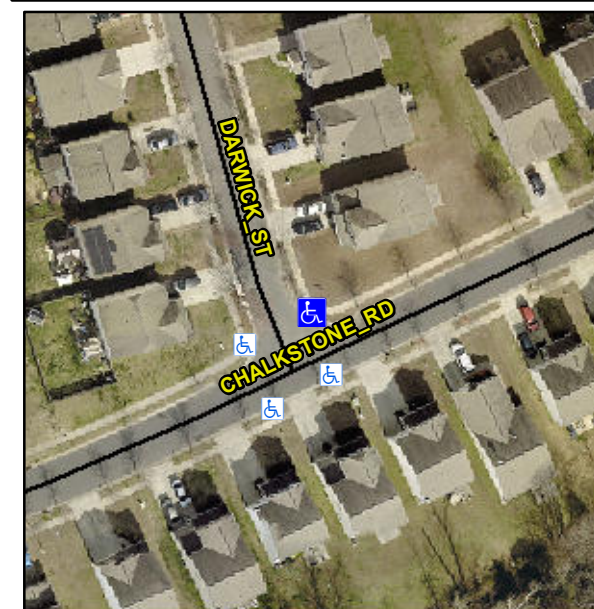
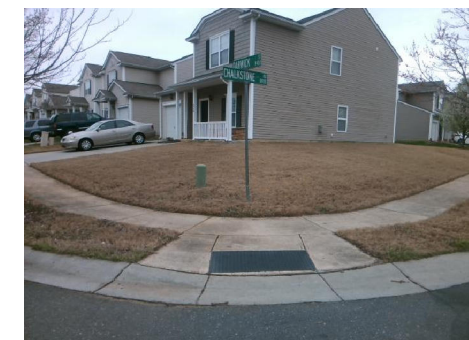
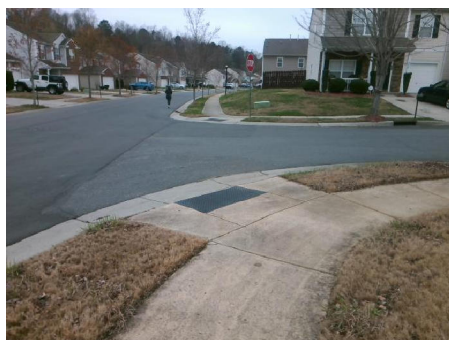
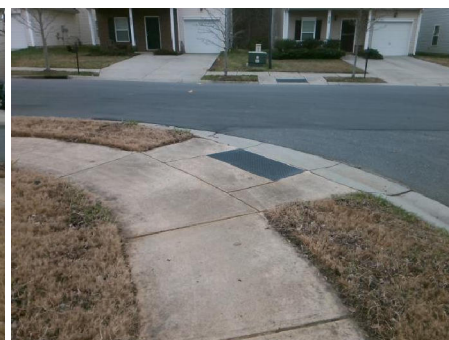
**Not Found, R304.5.1, R304.5.3**

Compliance	Description	Data	Compliance	Description	Data
N/A	Ramp Length (in)	53.0	Yes	Ramp Slope (%)	6.3
No	Ramp Width (in)	46.5	No	Ramp XSlope (%)	2.2
N/A	Flare Type LT	N/A	N/A	Flare Type RT	N/A
N/A	Flare Slope LT (%)	N/A	N/A	Flare Slope RT (%)	N/A
N/A	Flare Traversable LT?	N/A	N/A	Flare Traversable RT?	N/A
N/A	Landing Length (in)	N/A	N/A	DWS Provided?	N/A
N/A	Landing Width (in)	N/A	N/A	DWS Contrast?	N/A
N/A	Landing Slope (%)	N/A	N/A	DWS Length (in)	N/A
N/A	Landing X Slope (%)	N/A	N/A	DWS Full Width?	N/A
N/A	Landing Curb? (Y/N)	N/A	N/A	DWS Offset (in)	N/A
N/A	Shared Landing?	N/A			
N/A	Gutter Ponding?	N/A	N/A	Gutter Slope (%)	N/A
N/A	Gutter Lip Ht (in)	N/A	N/A	Gutter X Slope (%)	N/A
N/A	Painted X Walk1?	No	N/A	Painted X Walk2?	No
	X Walk 1 Direction	To W		X Walk 2 Direction	To S
N/A	X Walk 1 Width (in)	N/A	N/A	X Walk 2 Width (in)	N/A
	X Walk 1 Slope (%)	2.3		X Walk 2 Slope (%)	3.0
	X Walk 1 X Slope (%)	1.4		X Walk 2 X Slope (%)	1.7

N/A	Ramp inside XWalk1?	N/A	N/A	Ramp inside XWalk2?	N/A
	Road Slope (%)	1.0	N/A	Clear Space?	N/A
	Road X Slope (%)	2.6	N/A	Clear Space to XWalk (in)	N/A
N/A	Any Obstructions?	N/A	N/A	Storm Grate/Utility Hazard?	N/A
	Obstruction Type			Storm Grate/Utility Type	
		N/A			N/A
			Yes	Surface Condition? (G/P)	Good

**Remove & Replace Curb Ramp With Two New Directional Ramps or Equivalent.**
