Intersection ID: 48559	Main Street: RIDGEFOREST_DR	Cross Street: ARDREY_WOODS_DR	Location:	N
ADA ID: DF56F57C5094	Ramp Type: PerpDiag	Initial Pass/Fail: Fail	Overall Compliance: No	Severity Score: 8.75

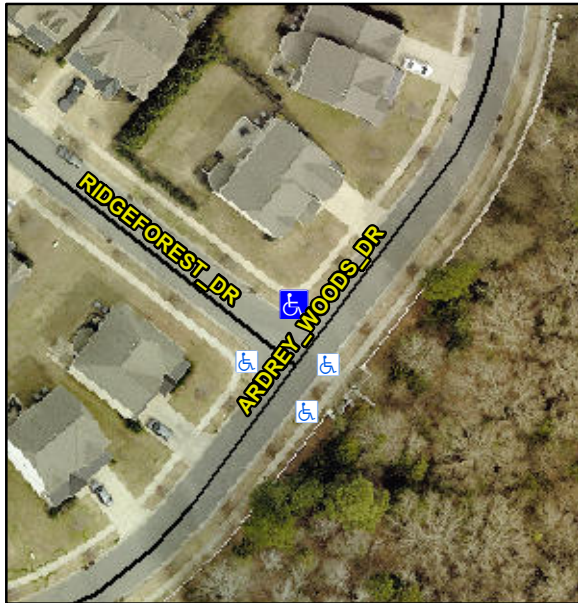
Not Found, R304.5.1

Compliance	Description	Data	Compliance	Description	Data
N/A	Ramp Length (in)	81.0	Yes	Ramp Slope (%)	6.4
No	Ramp Width (in)	47.0	Yes	Ramp XSlope (%)	0.4
N/A	Flare Type LT	N/A	N/A	Flare Type RT	N/A
N/A	Flare Slope LT (%)	N/A	N/A	Flare Slope RT (%)	N/A
N/A	Flare Traversable LT?	N/A	N/A	Flare Traversable RT?	N/A
N/A	Landing Length (in)	N/A	N/A	DWS Provided?	N/A
N/A	Landing Width (in)	N/A	N/A	DWS Contrast?	N/A
N/A	Landing Slope (%)	N/A	N/A	DWS Length (in)	N/A
N/A	Landing X Slope (%)	N/A	N/A	DWS Full Width?	N/A
N/A	Landing Curb? (Y/N)	N/A	N/A	DWS Offset (in)	N/A
N/A	Shared Landing?	N/A			
N/A	Gutter Ponding?	N/A	N/A	Gutter Slope (%)	N/A
N/A	Gutter Lip Ht (in)	N/A	N/A	Gutter X Slope (%)	N/A
N/A	Painted X Walk1?	No	N/A	Painted X Walk2?	No
	X Walk 1 Direction	To SW		X Walk 2 Direction	To SE
N/A	X Walk 1 Width (in)	N/A	N/A	X Walk 2 Width (in)	N/A
	X Walk 1 Slope (%)	0.4		X Walk 2 Slope (%)	1.3
	X Walk 1 X Slope (%)	1.6		X Walk 2 X Slope (%)	0.3

N/A	Ramp inside XWalk1?	N/A	N/A	Ramp inside XWalk2?	N/A
	Road Slope (%)	1.1	N/A	Clear Space?	N/A
	Road X Slope (%)	1.4	N/A	Clear Space to XWalk (in)	N/A
N/A	Any Obstructions?	N/A	N/A	Storm Grate/Utility Hazard?	N/A
	Obstruction Type			Storm Grate/Utility Type	
		N/A			N/A
			Yes	Surface Condition? (G/P)	Good

Possible Solutions:

Remove & Replace Curb Ramp With Two New Directional Ramps or Equivalent.

Total Cost: \$ 3200.00

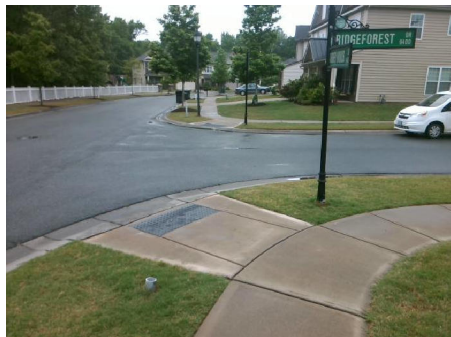
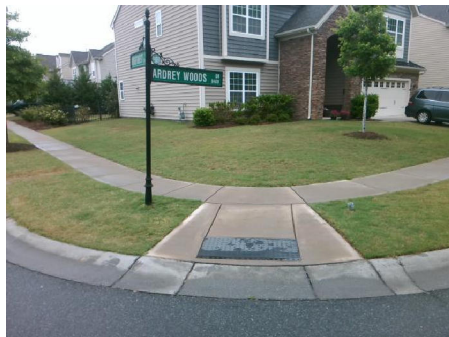
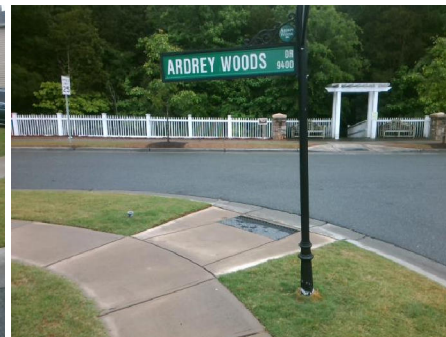
Street 1 Name	RIDGEFOREST DR
Stop Condition-Street 2	StopSign
Street 2 Name	ARDREY WOODS DR
Stop Condition-Street 1	None
