Access Compliance Report Public Rights-of-Way (Curb Ramps)

Intersection ID: 10674 Main Street: E W T HARRIS BV Cross Street: MARKWAY DR Location: SW

ADA ID: DF57987D6E8B Ramp Type: PerpDiag Initial Pass/Fail: Pass Overall Compliance: No Severity Score: 10

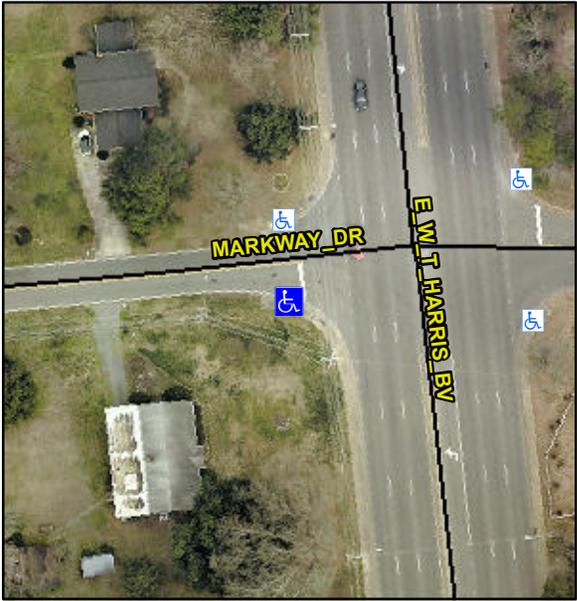
PROW/ADA:
Not Found, R304.2.1, R304.2.2-Perp, R304.3.2-Para, R304.5.3, R305.2, R302.7

Compliance	Description	Data	Compliance	Description	Data
N/A	Ramp Length (in)	60.5	Yes	Ramp Slope (%)	7.7
Yes	Ramp Width (in)	48.0	Yes	Ramp XSlope (%)	1.3
N/A	Flare Type LT	Sloped	N/A	Flare Type RT	N/A
N/A	Flare Slope LT (%)	6.7	Yes	Flare Slope RT (%)	5.2
N/A	Flare Traversable LT?	Yes	N/A	Flare Traversable RT?	Yes
No	Landing Length (in)	N/A	Yes	DWS Provided?	Yes
No	Landing Width (in)	N/A	Yes	DWS Contrast?	Yes
No	Landing Slope (%)	N/A	Yes	DWS Length (in)	24.0
No	Landing X Slope (%)	N/A	Yes	DWS Full Width?	Yes
N/A	Landing Curb? (Y/N)	No	No	DWS Offset (in)	3.5
N/A	Shared Landing?	N/A			
No	Gutter Ponding?	Yes	Yes	Gutter Slope (%)	4.3
Yes	Gutter Lip Ht (in)	0.0	Yes	Gutter X Slope (%)	0.8
N/A	Painted X Walk1?	No	N/A	Painted X Walk2?	No
	X Walk 1 Direction	To E		X Walk 2 Direction	To N
N/A	X Walk 1 Width (in)	N/A	N/A	X Walk 2 Width (in)	N/A
	X Walk 1 Slope (%)	2.1		X Walk 2 Slope (%)	2.6
	X Walk 1 X Slope (%)	1.1		X Walk 2 X Slope (%)	3.5

N/A	Ramp inside XWalk1?	N/A	N/A	Ramp inside XWalk2?	N/A
	Road Slope (%)	0.3	N/A	Clear Space?	Yes
	Road X Slope (%)	4.1	N/A	Clear Space to XWalk (in)	N/A
Yes	Any Obstructions?	No	Yes	Storm Grate/Utility Hazard?	No
	Obstruction Type			Storm Grate/Utility Type	
		N/A			N/A
			Yes	Surface Condition? (G/P)	Good

Possible Solutions:
Remove & Replace Curb Ramp With Two New Directional Ramps or Equivalent.

Total Cost: \$ **3200.00**
