Access Compliance Report

Public Rights-of-Way

(Curb Ramps)

Intersection ID: 13760	Main Street: EUCLID_AV	Cross Street: TEMPLETON_AV	Location: S
ADA ID: DF5BF3BD9D5C	Ramp Type: Directional1	Initial Pass/Fail: Fail	Overall Compliance: No
Severity Score: 61.25			
Codes/Mitigation Info/Possible Solution		Field Measurements/Component Compliance

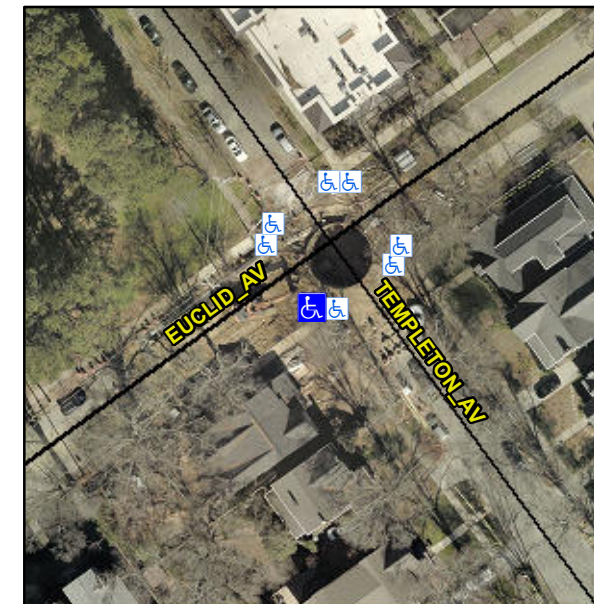
R304.5.1, R304.2.2, R304.5.3

Compliance	Description	Data	Compliance	Description	Data
N/A	Ramp Length (in)	36.0	N/A	Grade Break?	N/A
No	Ramp Width (in)	24.0	N/A	Grade Break Slope (%)	0.0
No	Ramp Slope (%)	13.3	N/A	Grade Break XSlope (%)	0.0
No	Ramp XSlope (%)	2.2			
N/A	Flare Type LT	N/A	N/A	Flare Type RT	N/A
N/A	Flare Slope LT (%)	N/A	N/A	Flare Slope RT (%)	0.0
N/A	Flare Traversable LT?	N/A	N/A	Flare Traversable RT?	N/A
N/A	Landing Length (in)	0.0	N/A	DWS Provided?	N/A
N/A	Landing Width (in)	0.0	N/A	DWS Contrast?	N/A
N/A	Landing Slope (%)	0.0	N/A	DWS Length (in)	N/A
N/A	Landing X Slope (%)	0.0	N/A	DWS Full Width?	N/A
N/A	Landing Curb? (Y/N)	N/A	N/A	DWS Offset LT (in)	N/A
N/A	Shared Landing?	N/A	N/A	DWS Offset RT (in)	N/A
N/A	Gutter Ponding?	0.0	N/A	Gutter Slope (%)	N/A
N/A	Gutter Lip Ht (in)	0.0	N/A	Gutter X Slope (%)	N/A
N/A	Painted X Walk1?	No		Road Slope (%)	6.1
	X Walk 1 Direction	To NW		Road X Slope (%)	4.1
	X Walk 1 Width (in)	N/A		Clear Space?	N/A

X Walk 1 Slope (%)	6.1	N/A	Clear Space to XWalk (in)	N/A
	X Walk 1 X Slope (%)	4.1	N/A	Storm Grate/Utility Hazard?	N/A
N/A	Ramp inside XWalk1?	N/A		Storm Grate/Utility Type	
N/A	Any Obstructions?	N/A			N/A
	Obstruction Type		Yes	Surface Condition? (G/P)	Good
			N/A	Curb Slope (%)	4.3

Possible Solutions:

Remove & Replace Entire Ramp.
