Access Compliance Report

Public Rights-of-Way

(Curb Ramps)

Intersection ID: 1001734	Main Street: FLAT_RIVER_DR	Cross Street: OVERLAND_PARK_LN	Location:	N
ADA ID: DF6CBB5586F0	Ramp Type: Perp	Initial Pass/Fail: Fail	Overall Compliance: No	Severity Score: 37.5
Codes/Mitigation Info/Possible Solution		Field Measurements/Component Compliance

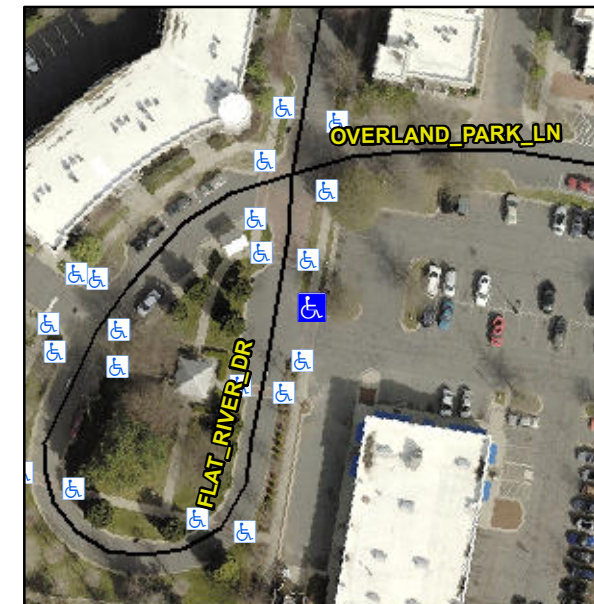
R304.2.2, R304.5.3

Compliance	Description	Data	Compliance	Description	Data
N/A	Ramp Length (in)	74.5	No	Ramp Slope (%)	13.3
Yes	Ramp Width (in)	48.5	No	Ramp XSlope (%)	5.7
N/A	Flare Type LT	N/A	N/A	Flare Type RT	N/A
N/A	Flare Slope LT (%)	N/A	N/A	Flare Slope RT (%)	N/A
N/A	Flare Traversable LT?	N/A	N/A	Flare Traversable RT?	N/A
N/A	Landing Length (in)	N/A	N/A	DWS Provided?	N/A
N/A	Landing Width (in)	N/A	N/A	DWS Contrast?	N/A
N/A	Landing Slope (%)	N/A	N/A	DWS Length (in)	N/A
N/A	Landing X Slope (%)	N/A	N/A	DWS Full Width?	N/A
N/A	Landing Curb? (Y/N)	N/A	N/A	DWS Offset (in)	N/A
N/A	Shared Landing?	N/A			
N/A	Gutter Ponding?	N/A	N/A	Gutter Slope (%)	N/A
N/A	Gutter Lip Ht (in)	N/A	N/A	Gutter X Slope (%)	N/A
N/A	Painted X Walk1?	Yes	N/A	Painted X Walk2?	N/A
	X Walk 1 Direction	To S		X Walk 2 Direction	N/A
N/A	X Walk 1 Width (in)	51.0	N/A	X Walk 2 Width (in)	N/A
	X Walk 1 Slope (%)	2.1		X Walk 2 Slope (%)	N/A
	X Walk 1 X Slope (%)	2.4		X Walk 2 X Slope (%)	N/A

N/A	Ramp inside XWalk1?	Yes	N/A	Ramp inside XWalk2?	N/A
	Road Slope (%)	N/A	N/A	Clear Space?	N/A
	Road X Slope (%)	N/A	N/A	Clear Space to XWalk (in)	N/A
N/A	Any Obstructions?	N/A	N/A	Storm Grate/Utility Hazard?	N/A
	Obstruction Type			Storm Grate/Utility Type	
		N/A			N/A
			Yes	Surface Condition? (G/P)	Good

Possible Solutions:

Remove & Replace Entire Ramp.
