Access Compliance Report

Public Rights-of-Way

(Curb Ramps)

Intersection ID: 14086	Main Street: BALDWIN_AV	Cross Street: E_3RD_ST	Location: W
ADA ID: DF6D58CCA7DA	Ramp Type: Perp	Initial Pass/Fail: Fail	Overall Compliance: No
Severity Score: 18.75			
Codes/Mitigation Info/Possible Solution		Field Measurements/Component Compliance

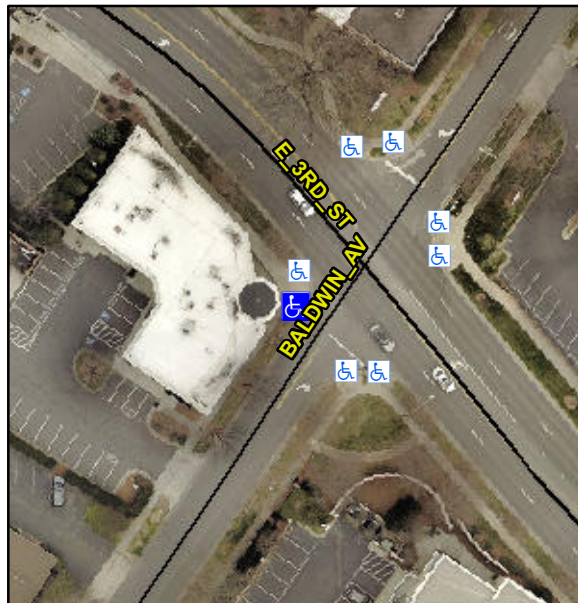
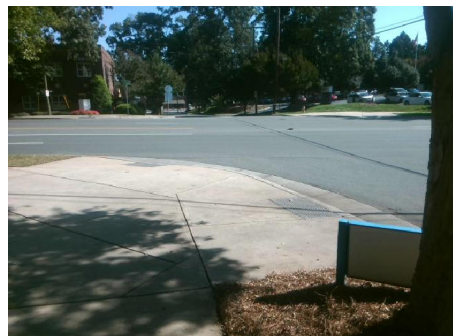
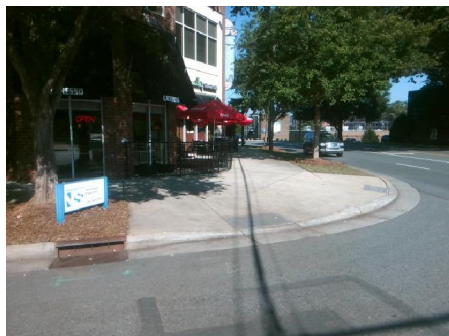
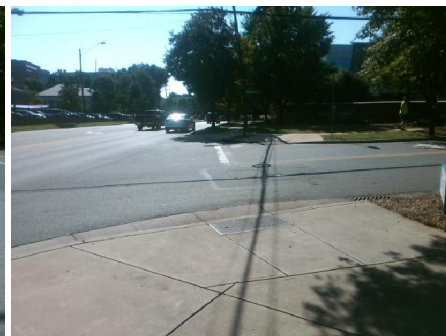
Not Found, R304.5.1, R304.5.3

Compliance	Description	Data	Compliance	Description	Data
N/A	Ramp Length (in)	90.0	Yes	Ramp Slope (%)	5.2
No	Ramp Width (in)	33.0	No	Ramp XSlope (%)	3.0
N/A	Flare Type LT	N/A	N/A	Flare Type RT	N/A
N/A	Flare Slope LT (%)	N/A	N/A	Flare Slope RT (%)	N/A
N/A	Flare Traversable LT?	N/A	N/A	Flare Traversable RT?	N/A
N/A	Landing Length (in)	N/A	N/A	DWS Provided?	N/A
N/A	Landing Width (in)	N/A	N/A	DWS Contrast?	N/A
N/A	Landing Slope (%)	N/A	N/A	DWS Length (in)	N/A
N/A	Landing X Slope (%)	N/A	N/A	DWS Full Width?	N/A
N/A	Landing Curb? (Y/N)	N/A	N/A	DWS Offset (in)	N/A
N/A	Shared Landing?	N/A			
N/A	Gutter Ponding?	N/A	N/A	Gutter Slope (%)	N/A
N/A	Gutter Lip Ht (in)	N/A	N/A	Gutter X Slope (%)	N/A
N/A	Painted X Walk1?	No	N/A	Painted X Walk2?	N/A
	X Walk 1 Direction	To SE		X Walk 2 Direction	N/A
N/A	X Walk 1 Width (in)	N/A	N/A	X Walk 2 Width (in)	N/A
	X Walk 1 Slope (%)	0.7		X Walk 2 Slope (%)	N/A
	X Walk 1 X Slope (%)	0.5		X Walk 2 X Slope (%)	N/A

N/A	Ramp inside XWalk1?	N/A	N/A	Ramp inside XWalk2?	N/A
	Road Slope (%)	N/A	N/A	Clear Space?	N/A
	Road X Slope (%)	N/A	N/A	Clear Space to XWalk (in)	N/A
N/A	Any Obstructions?	N/A	N/A	Storm Grate/Utility Hazard?	N/A
	Obstruction Type			Storm Grate/Utility Type	
		N/A			N/A
			Yes	Surface Condition? (G/P)	Good

Possible Solutions:

Remove & Replace Entire Ramp.
