Access Compliance Report Public Rights-of-Way (Curb Ramps)

Intersection ID: 45181 Main Street: SOCIETY_ST **Cross Street: WESTON_GLEN_DR** Location: SE **Severity Score: ADA ID: DF713A14BD70** Ramp Type: Perp Initial Pass/Fail: Fail **Overall Compliance: No** 8.75

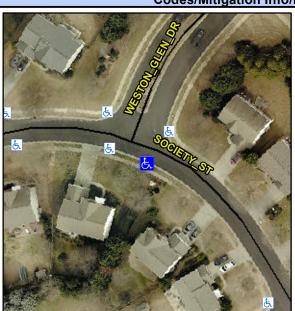
Field Measurements/Component Compliance							
Compliance Description		Data	Comp	oliance Description	Data		
N/A	Ramp Length (in)	49.0	Yes	Ramp Slope (%)	7.7		
No	Ramp Width (in)	40.0	Yes	Ramp XSlope (%)	0.3		
N/A	Flare Type LT	N/A	N/A	Flare Type RT	N/A		
N/A	Flare Slope LT (%)	N/A	N/A	Flare Slope RT (%)	N/A		
N/A	Flare Traversable LT?	N/A	N/A	Flare Traversable RT?	N/A		
N/A	Landing Length (in)	N/A	N/A	DWS Provided?	N/A		
N/A	Landing Width (in)	N/A	N/A	DWS Contrast?	N/A		
N/A	Landing Slope (%)	N/A	N/A	DWS Length (in)	N/A		
N/A	Landing X Slope (%)	N/A	N/A	DWS Full Width?	N/A		
N/A	Landing Curb? (Y/N)	N/A	N/A	DWS Offset (in)	N/A		
N/A	Shared Landing?	N/A					
N/A	Gutter Ponding?	N/A	N/A	Gutter Slope (%)	N/A		
N/A	Gutter Lip Ht (in)	N/A	N/A	Gutter X Slope (%)	N/A		
N/A	Painted X Walk1?	No	N/A	Painted X Walk2?	N/A		
	X Walk 1 Direction	To NE		X Walk 2 Direction	N/A		
N/A	X Walk 1 Width (in)	N/A	N/A	X Walk 2 Width (in)	N/A

X Walk 1 Slope (%)	3.3		X Walk 2 Slope (%)	N/A		
	X Walk 1 X Slope (%)	0.1		X Walk 2 X Slope (%)	N/A		
N/A	Ramp inside XWalk1?	N/A	N/A	Ramp inside XWalk2?	N/A		
	Road Slope (%)	N/A	N/A	Clear Space?	N/A		
	Road X Slope (%)	N/A	N/A	Clear Space to XWalk (in)	N/A		
N/A	Any Obstructions?	N/A	N/A	Storm Grate/Utility Hazard?	N/A		
	Obstruction Type			Storm Grate/Utility Type			
		N/A			N/A		
			Yes	Surface Condition? (G/P)	Good		
	Military.

Possible Solutions:	Co		
Remove & Replace Entire Ramp.			
	No		
	N/A		
Surveyor Notes:	N/A		
N/A	N/A		
	N/A		
	N/A		
	N/A		
PROW/ADA:	N/A		
Not Found, R304.5.1	N/A		
	N/A		
	N/A		
	N/

Total Cost: 1850.00
