## Access Compliance Report Public Rights-of-Way (Curb Ramps)

Intersection ID: 16020Main Street:MONROE\_RDCross Street:COMMONWEALTH AVLocation:NWADA ID: DF72D2959A65Ramp Type:PerpDiagInitial Pass/Fail:FailOverall Compliance:NoSeverity Score:37.5

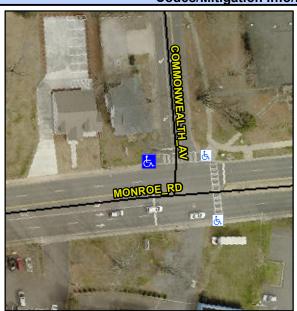
PROW/ADA:
Not Found, R304.2.2, R304.5.3

Fleid Measurements/Component Compliance					
Compliance Description		Data	Compliance Description		Data
N/A	Ramp Length (in)	61.0	No	Ramp Slope (%)	14.9
Yes	Ramp Width (in)	48.0	No	Ramp XSlope (%)	6.1
N/A	Flare Type LT	N/A	N/A	Flare Type RT	N/A
N/A	Flare Slope LT (%)	N/A	N/A	Flare Slope RT (%)	N/A
N/A	Flare Traversable LT?	N/A	N/A	Flare Traversable RT?	N/A
N/A	Landing Length (in)	N/A	N/A	DWS Provided?	N/A
N/A	Landing Width (in)	N/A	N/A	DWS Contrast?	N/A
N/A	Landing Slope (%)	N/A	N/A	DWS Length (in)	N/A
N/A	Landing X Slope (%)	N/A	N/A	DWS Full Width?	N/A
N/A	Landing Curb? (Y/N)	N/A	N/A	DWS Offset (in)	N/A
N/A	Shared Landing?	N/A			
N/A	Gutter Ponding?	N/A	N/A	Gutter Slope (%)	N/A
N/A	Gutter Lip Ht (in)	N/A	N/A	Gutter X Slope (%)	N/A
N/A	Painted X Walk1?	No	N/A	Painted X Walk2?	Yes
	X Walk 1 Direction	To S		X Walk 2 Direction	To E
N/A	X Walk 1 Width (in)	N/A	N/A	X Walk 2 Width (in)	111.0
	X Walk 1 Slope (%)	0.3		X Walk 2 Slope (%)	0.3

X Walk 1 X Slope (%)	0.7		X Walk 2 X Slope (%)	0.9
N/A	Ramp inside XWalk1?	N/A	N/A	Ramp inside XWalk2?	Yes
	Road Slope (%)	0.4	N/A	Clear Space?	N/A
	Road X Slope (%)	0.4	N/A	Clear Space to XWalk (in)	N/A
N/A	Any Obstructions?	N/A	N/A	Storm Grate/Utility Hazard?	N/A
	Obstruction Type			Storm Grate/Utility Type	
		N/A			N/A
			Yes	Surface Condition? (G/P)	Good

Possible Solutions:

Remove & Replace Curb Ramp With
Two New Directional Ramps or
Equivalent.
