Access Compliance Report

Public Rights-of-Way

(Curb Ramps)

Intersection ID: 20488	Main Street: FARMHURST_DR	Cross Street: HIGH_MEADOW_LN	Location: NE
ADA ID: DF73179FAA29	Ramp Type: PerpDiag	Initial Pass/Fail: Fail	Overall Compliance: No
Codes/Mitigation Info/Possible Solution		Field Measurements/Component Compliance

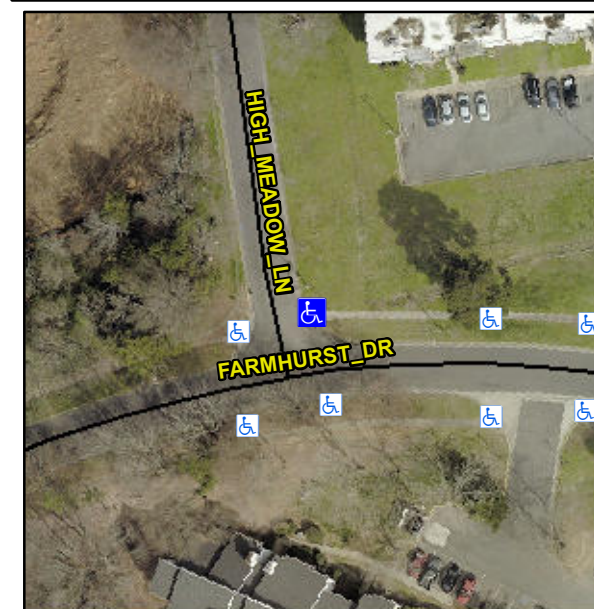
Not Found, R304.5.1, R304.5.3

Compliance	Description	Data	Compliance	Description	Data
N/A	Ramp Length (in)	93.0	Yes	Ramp Slope (%)	6.5
No	Ramp Width (in)	47.5	No	Ramp XSlope (%)	3.8
N/A	Flare Type LT	N/A	N/A	Flare Type RT	N/A
N/A	Flare Slope LT (%)	N/A	N/A	Flare Slope RT (%)	N/A
N/A	Flare Traversable LT?	N/A	N/A	Flare Traversable RT?	N/A
N/A	Landing Length (in)	N/A	N/A	DWS Provided?	N/A
N/A	Landing Width (in)	N/A	N/A	DWS Contrast?	N/A
N/A	Landing Slope (%)	N/A	N/A	DWS Length (in)	N/A
N/A	Landing X Slope (%)	N/A	N/A	DWS Full Width?	N/A
N/A	Landing Curb? (Y/N)	N/A	N/A	DWS Offset (in)	N/A
N/A	Shared Landing?	N/A			
N/A	Gutter Ponding?	N/A	N/A	Gutter Slope (%)	N/A
N/A	Gutter Lip Ht (in)	N/A	N/A	Gutter X Slope (%)	N/A
N/A	Painted X Walk1?	No	N/A	Painted X Walk2?	No
	X Walk 1 Direction	To W		X Walk 2 Direction	To S
N/A	X Walk 1 Width (in)	N/A	N/A	X Walk 2 Width (in)	N/A
	X Walk 1 Slope (%)	4.7		X Walk 2 Slope (%)	3.4
	X Walk 1 X Slope (%)	2.4		X Walk 2 X Slope (%)	2.6

N/A	Ramp inside XWalk1?	N/A	N/A	Ramp inside XWalk2?	N/A
	Road Slope (%)	3.5	N/A	Clear Space?	N/A
	Road X Slope (%)	4.0	N/A	Clear Space to XWalk (in)	N/A
N/A	Any Obstructions?	N/A	N/A	Storm Grate/Utility Hazard?	N/A
	Obstruction Type			Storm Grate/Utility Type	
		N/A			N/A
			Yes	Surface Condition? (G/P)	Good

Remove & Replace Curb Ramp With Two New Directional Ramps or Equivalent.
