# Access Compliance Report

## Public Rights-of-Way

### (Curb Ramps)

| Intersection ID: 45984 | Main Street: CHESTERBROOK_LN | Cross Street: MASON MILL_PL | Location: W |

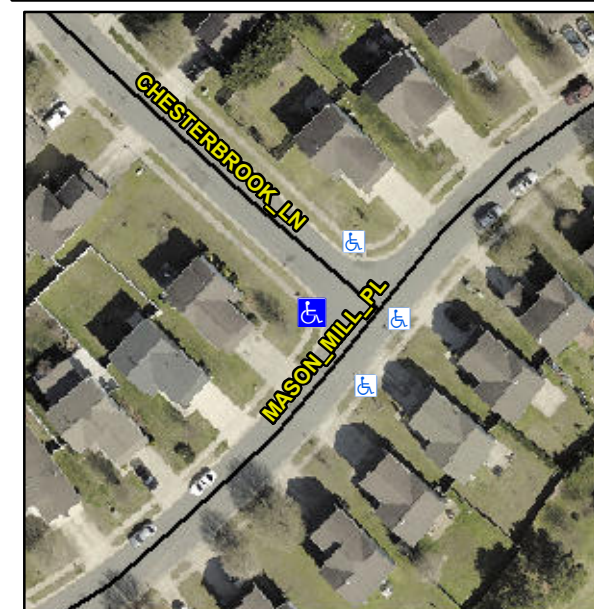
| ADA ID: DF7ECECAEB4E | Ramp Type: PerpDiag | Initial Pass/Fail: Fail | Overall Compliance: No |
| Severity Score: 46.25 | | | |

**R304.5.1, R304.2.2, R304.5.3**

| Compliance | Description | Data | Compliance | Description | Data |
|---|---|---|---|---|---|
| N/A | Ramp Length (in) | 50.0 | No | Ramp Slope (%) | 9.0 |
| No | Ramp Width (in) | 41.0 | No | Ramp XSlope (%) | 8.6 |

**Remove & Replace Curb Ramp With Two New Directional Ramps or Equivalent.**

Total Cost: \$ 3200.00
