## Access Compliance Report Public Rights-of-Way (Curb Ramps)

Intersection ID: 52457Main Street:ORCHARD\_LAKE\_DRCross Street:LUCY\_JANE\_LNLocation:SWADA ID: DF7ED42228D2Ramp Type:Directional1Initial Pass/Fail:FailOverall Compliance:NoSeverity Score:1.25

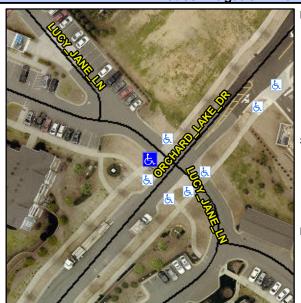
Field Measurements/Component Compliance							
Compl	liance Description	Data	Comp	liance Description	Data		
N/A	Ramp Length (in)	52.0	N/A	Grade Break?	N/A		
Yes	Ramp Width (in)	71.5	N/A	Grade Break Slope (%)	0.0		
Yes	Ramp Slope (%)	3.7	N/A	Grade Break XSlope (%)	0.0		
No	Ramp XSlope (%)	3.8					
N/A	Flare Type LT	N/A	N/A	Flare Type RT	N/A		
N/A	Flare Slope LT (%)	N/A	N/A	Flare Slope RT (%)	0.		
N/A	Flare Traversable LT?	N/A	N/A	Flare Traversable RT?	N/A		
N/A	Landing Length (in)	0.0	N/A	DWS Provided?	N/A		
N/A	Landing Width (in)	0.0	N/A	DWS Contrast?	N/A		
N/A	Landing Slope (%)	0.0	N/A	DWS Length (in)	N/A		
N/A	Landing X Slope (%)	0.0	N/A	DWS Full Width?	N/A		
N/A	Landing Curb? (Y/N)	N/A	N/A	DWS Offset LT (in)	N/A		
N/A	Shared Landing?	N/A	N/A	DWS Offset RT (in)	N/A		
N/A	Gutter Ponding?	0.0	N/A	Gutter Slope (%)	N/A		
N/A	Gutter Lip Ht (in)	0.0	N/A	Gutter X Slope (%)	N/A		
N/A	Painted X Walk1?	No		Road Slope (%)	0.

X Walk 1 Direction	To NE		Road X Slope (%)	2.		
	X Walk 1 Width (in)	N/A		Clear Space?	N/A		
	X Walk 1 Slope (%)	0.3	N/A	Clear Space to XWalk (in)	N/A		
	X Walk 1 X Slope (%)	2.0	N/A	Storm Grate/Utility Hazard?	N/A		
N/A	Ramp inside XWalk1?	N/A		Storm Grate/Utility Type			
N/A	Any Obstructions?	N/A			N/A		
	Obstruction Type		Yes	Surface Condition? (G/P)	Good		
		N/A	N/A	Curb Slope (%)	4.

Possible Solutions:
Remove & Replace Entire Ramp.
Surveyor Notes:
N/A
PROW/ADA:
R304.5.3
