# Access Compliance Report

## Public Rights-of-Way

### (Curb Ramps)

Intersection ID: 19093	Main Street: BRAEBURN_RD	Cross Street: GATE_POST_RD	Location:	N
ADA ID: DF887A375E51	Ramp Type: BlendTrans2	Initial Pass/Fail: Fail	Overall Compliance: No	Severity Score: 33.75

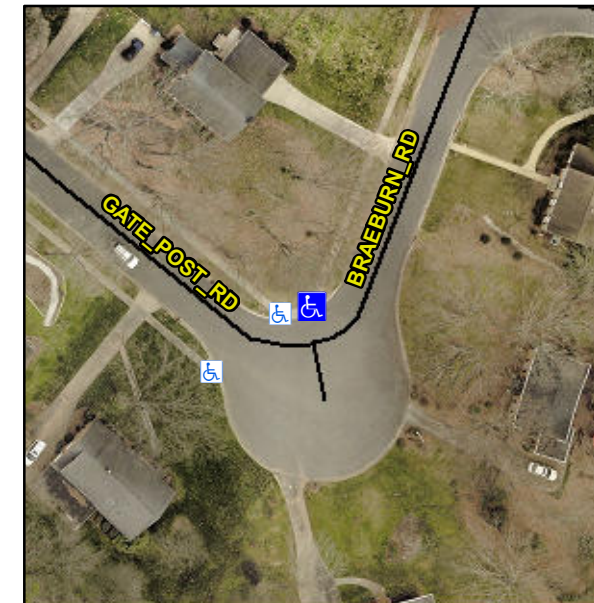
**NO LNDG**

**Not Found, R304.5.1, R304.5.3**

Compliance	Description	Data	Compliance	Description	Data
N/A	Ramp Length (in)	65.0	Yes	BlendTrans Slope (%)	4.0
No	Ramp Width (in)	47.0	No	BlendTrans XSlope (%)	7.4
N/A	Flare Type LT	N/A	N/A	Flare Type RT	N/A
N/A	Flare Slope LT (%)	N/A	N/A	Flare Slope RT (%)	N/A
N/A	Flare Traversable LT?	N/A	N/A	Flare Traversable RT?	N/A
N/A	Landing Length (in)	N/A	N/A	DWS Provided?	N/A
N/A	Landing Width (in)	N/A	N/A	DWS Contrast?	N/A
N/A	Landing Slope (%)	N/A	N/A	DWS Length (in)	N/A
N/A	Landing X Slope (%)	N/A	N/A	DWS Full Width?	N/A
N/A	Landing Curb? (Y/N)	N/A	N/A	DWS Offset (in)	N/A
N/A	Shared Landing?	N/A			
N/A	Gutter Ponding?	N/A	N/A	Gutter Slope (%)	N/A
N/A	Gutter Lip Ht (in)	N/A	N/A	Gutter X Slope (%)	N/A
N/A	Painted X Walk1?	No	N/A	Painted X Walk2?	N/A
	X Walk 1 Direction	To SE		X Walk 2 Direction	N/A
	X Walk 1 Width (in)	N/A		X Walk 2 Width (in)	N/A
	X Walk 1 Slope (%)	4.0		X Walk 2 Slope (%)	N/A
	X Walk 1 X Slope (%)	7.3		X Walk 2 X Slope (%)	N/A

N/A	Ramp inside XWalk1?	N/A	N/A	Ramp inside XWalk2?	N/A
	Road Slope (%)	7.3		Clear Space?	N/A
	Road X Slope (%)	4.0	N/A	Clear Space to XWalk (in)	N/A
N/A	Any Obstructions?	N/A	N/A	Storm Grate/Utility Hazard?	N/A
	Obstruction Type			Storm Grate/Utility Type	
		N/A			N/A
			Yes	Surface Condition? (G/P)	Good
			No	Curb Slope (%)	9.7

**Remove & Replace Curb Ramp With Two New Directional Ramps or Equivalent.**
