Access Compliance Report

Public Rights-of-Way (Curb Ramps)

Intersection ID: 6798	Main Street: OAKWOOD_DR	Cross Street: STATESVILLE_RD	Location: SW
ADA ID: DF9528641A60	Ramp Type: Para	Initial Pass/Fail: Fail	Overall Compliance: No
			Severity Score: 13.75

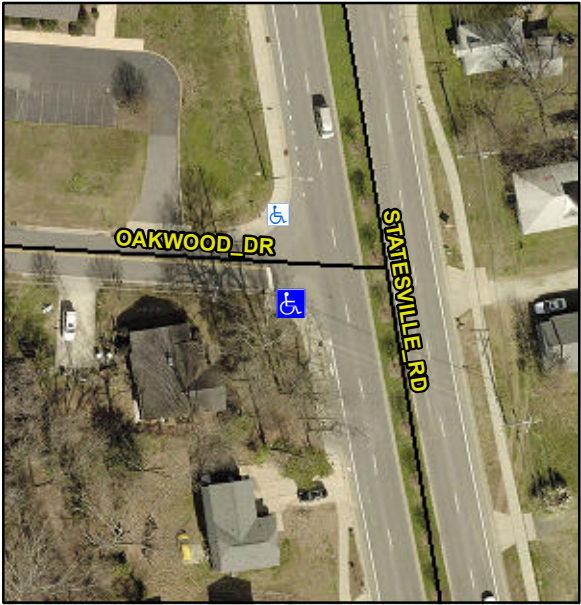
Possible Solutions:		Compliance	Description	Data
	Remove & Replace Entire Ramp.		N/A	Ramp Length LT (in)	48.0
			Yes	Ramp Width LT (in)	84.0
			Yes	Ramp Slope LT (%)	7.7
			No	Ramp XSlope LT (%)	3.2
			N/A	Landing Length (in)	N/A
			N/A	Landing Width (in)	N/A
			N/A	Landing Slope (%)	N/A
			N/A	Landing X Slope (%)	N/A
			N/A	Landing Curb? (Y/N)	N/A
<p>Surveyor Notes:</p> <p>N/A</p> <p>PROW/ADA:</p> <p>R304.5.3, R304.3.2</p>			N/A	Ramp XSlope RT (%)	2.4
			N/A	DWS Provided?	N/A
			N/A	DWS Contrast?	N/A
			N/A	DWS Length (in)	N/A
			N/A	DWS Full Width?	N/A
			N/A	DWS Offset (in)	N/A
			N/A	Gutter Slope (%)	N/A
			N/A	Gutter X Slope (%)	N/A
			N/A	Painted X Walk1?	No
			N/A	Painted X Walk2?	N/A
			N/A	X Walk 1 Direction	To N
			N/A	X Walk 1 Width (in)	N/A
			N/A	X Walk 1 Slope (%)	2.6
			N/A	X Walk 1 X Slope (%)	0.3
			N/A	Ramp inside XWalk1?	N/A

N/A	Ramp inside XWalk2?	N/A
			N/A	Road Slope (%)	N/A
			N/A	Road X Slope (%)	N/A
			N/A	Any Obstructions?	N/A
			N/A	Obstruction Type	
Total Cost:			\$	1600.00	
			N/A		N/A
			Yes	Surface Condition? (G/P)	Good
			N/A	Curb Slope (%)	10.2
