# Access Compliance Report Public Rights-of-Way (Curb Ramps)

Intersection ID: 19986	Main Street: ARCHDALE_DR	Cross Street: SOUTH_BV	Location: NW
ADA ID: DF95769272DA	Ramp Type: Combination1Diag	Initial Pass/Fail: Fail	Overall Compliance: No Severity Score: 0

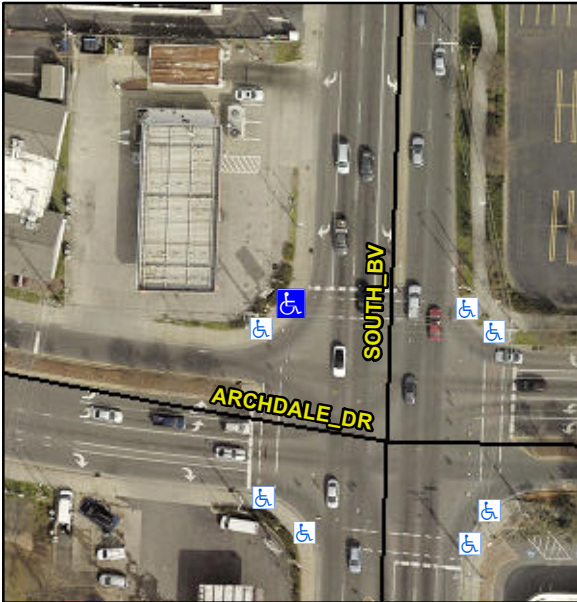
Compliance	Description	Data	Compliance	Description	Data
N/A	Ramp Length LT (in)	58.0	N/A	Ramp Length RT (in)	57.0
Yes	Ramp Width LT (in)	92.0	Yes	Ramp Width RT (in)	93.0
No	Ramp Slope LT (%)	9.4	Yes	Ramp Slope RT (%)	5.9
No	Ramp XSlope LT (%)	2.4	Yes	Ramp XSlope RT (%)	1.5
N/A	Ramp Length (in)	28.0	Yes	Ramp Slope (%)	6.4
Yes	Ramp Width (in)	48.0	Yes	Ramp XSlope (%)	0.9
N/A	Flare Type LT	N/A	N/A	Flare Type RT	N/A
N/A	Flare Slope LT (%)	N/A	N/A	Flare Slope RT (%)	N/A
N/A	Flare Traversable LT?	N/A	N/A	Flare Traversable RT?	N/A
N/A	Landing Length (in)	N/A	N/A	DWS Provided?	N/A
N/A	Landing Width (in)	N/A	N/A	DWS Contrast?	N/A
N/A	Landing Slope (%)	N/A	N/A	DWS Length (in)	N/A
N/A	Landing X Slope (%)	N/A	N/A	DWS Full Width?	N/A
N/A	Landing Curb? (Y/N)	N/A	N/A	DWS Offset (in)	N/A
N/A	Shared Landing?	N/A			
N/A	Gutter Ponding?	N/A	N/A	Gutter Slope (%)	N/A
N/A	Gutter Lip Ht (in)	N/A	N/A	Gutter X Slope (%)	N/A
N/A	Painted X Walk1?	Yes	N/A	Painted X Walk2?	No

X Walk 1 Direction	To S		X Walk 2 Direction	To E
	X Walk 1 Width (in)	109.0		X Walk 2 Width (in)	N/A
	X Walk 1 Slope (%)	1.0		X Walk 2 Slope (%)	N/A
	X Walk 1 X Slope (%)	1.4		X Walk 2 X Slope (%)	N/A
N/A	Ramp inside XWalk1?	Yes	N/A	Ramp inside XWalk2?	N/A
	Road Slope (%)	N/A		Clear Space?	N/A
	Road X Slope (%)	N/A	N/A	Clear Space to XWalk (in)	N/A
			N/A	Any Obstruction?	N/A
				Obstruction Type	N/A
			N/A	Storm Grate/Utility Hazard?	N/A
				Storm Grate/Utility Type	N/A
Yes	Surface Condition? (G/P)				Good
	Curb Slope (%)				3.8

Possible Solutions:  
**Remove & Replace Curb Ramp With Two New Directional Ramps or Equivalent.**
