## Access Compliance Report Public Rights-of-Way (Curb Ramps)

Intersection ID: 10012508Main Street: MILTON\_RDCross Street: N/ALocation:NADA ID: DF959DC59903Ramp Type: ParaInitial Pass/Fail: FailOverall Compliance: NoSeverity Score: 13.75

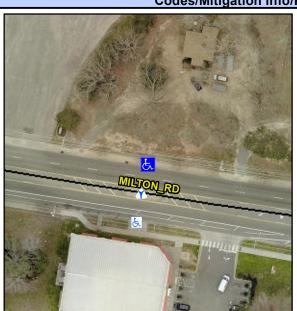
LT RP < 5%

R304.5.3, R304.3.2

Compliance Description Data Compliance Description Da					
N/A	Ramp Length LT (in)	71.5	N/A	Ramp Length RT (in)	71.5
Yes	Ramp Width LT (in)	60.0	Yes	Ramp Width RT (in)	60.0
Yes	Ramp Slope LT (%)	4.5	No	Ramp Slope RT (%)	9.9
No	Ramp XSlope LT (%)	3.0	No	Ramp XSlope RT (%)	3.0
N/A	Landing Length (in)	N/A	N/A	DWS Provided?	N/A
N/A	Landing Width (in)	N/A	N/A	DWS Contrast?	N/A
N/A	Landing Slope (%)	N/A	N/A	DWS Length (in)	N/A
N/A	Landing X Slope (%)	N/A	N/A	DWS Full Width?	N/A
N/A	Landing Curb? (Y/N)	N/A	N/A	DWS Offset (in)	N/A
N/A	Shared Landing?	N/A			
N/A	Gutter Ponding?	N/A	N/A	Gutter Slope (%)	N/A
N/A	Gutter Lip Ht (in)	N/A	N/A	Gutter X Slope (%)	N/A
N/A	Painted X Walk1?	No	N/A	Painted X Walk2?	N/A
	X Walk 1 Direction	To S		X Walk 2 Direction	N/A
N/A	X Walk 1 Width (in)	N/A	N/A	X Walk 2 Width (in)	N/A
	X Walk 1 Slope (%)	2.0		X Walk 2 Slope (%)	N/A
	X Walk 1 X Slope (%)	2.3		X Walk 2 X Slope (%)	N/A
N/A	Ramp inside XWalk1?	N/A	N/A	Ramp inside XWalk2?	N/A

Road Slope (%)	N/A	N/A	Clear Space?	N/A
	Road X Slope (%)	N/A	N/A	Clear Space to XWalk (in)	N/A
N/A	Any Obstructions?	N/A	N/A	Storm Grate/Utility Hazard?	N/A
	Obstruction Type			Storm Grate/Utility Type	
		N/A			N/A
			Yes	Surface Condition? (G/P)	Good
			N/A	Curb Slope (%)	7.9

Remove & Replace Entire Ramp.

Total Cost: \$ 1600.00
