# Access Compliance Report

## Public Rights-of-Way

### (Curb Ramps)

Intersection ID: 20422	Main Street: W_ARROWWOOD_RD	Cross Street: S_TRYON_ST	Location: SW
ADA ID: DFA81E133A9E	Ramp Type: Perp	Initial Pass/Fail: Fail	Overall Compliance: No
Severity Score: 22.5			
Codes/Mitigation Info/Possible Solution		Field Measurements/Component Compliance

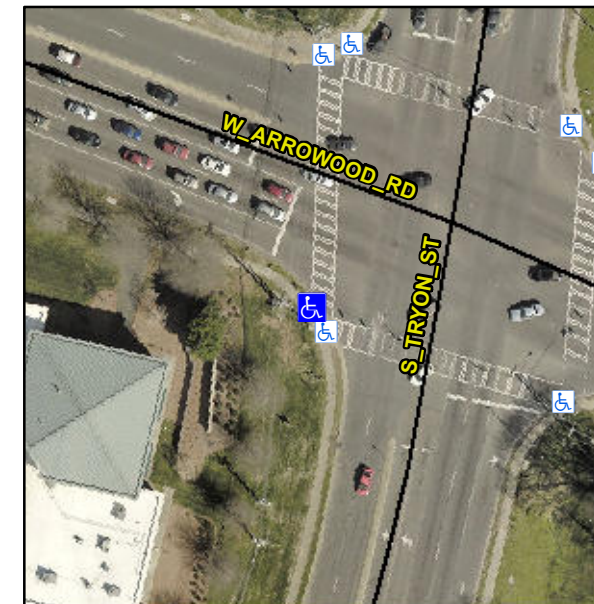
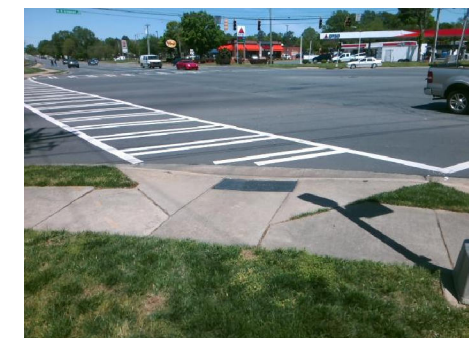
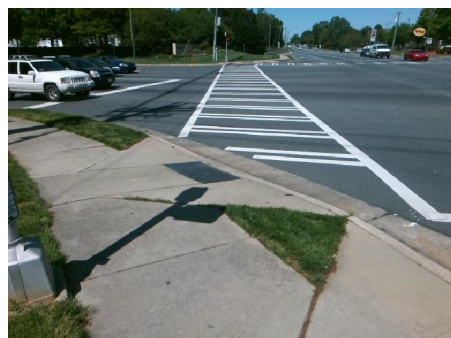
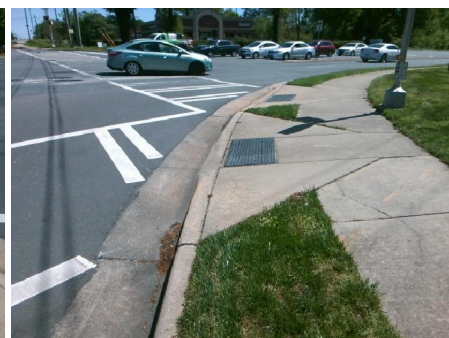
**Not Found, R304.5.1, R304.2.2**

Compliance	Description	Data	Compliance	Description	Data
N/A	Ramp Length (in)	75.0	No	Ramp Slope (%)	9.3
No	Ramp Width (in)	47.0	Yes	Ramp XSlope (%)	2.7
N/A	Flare Type LT	N/A	N/A	Flare Type RT	N/A
N/A	Flare Slope LT (%)	N/A	N/A	Flare Slope RT (%)	N/A
N/A	Flare Traversable LT?	N/A	N/A	Flare Traversable RT?	N/A
N/A	Landing Length (in)	N/A	N/A	DWS Provided?	N/A
N/A	Landing Width (in)	N/A	N/A	DWS Contrast?	N/A
N/A	Landing Slope (%)	N/A	N/A	DWS Length (in)	N/A
N/A	Landing X Slope (%)	N/A	N/A	DWS Full Width?	N/A
N/A	Landing Curb? (Y/N)	N/A	N/A	DWS Offset (in)	N/A
N/A	Shared Landing?	N/A			
N/A	Gutter Ponding?	N/A	N/A	Gutter Slope (%)	N/A
N/A	Gutter Lip Ht (in)	N/A	N/A	Gutter X Slope (%)	N/A
N/A	Painted X Walk1?	Yes	N/A	Painted X Walk2?	N/A
	X Walk 1 Direction	To N		X Walk 2 Direction	N/A
N/A	X Walk 1 Width (in)	132.0	N/A	X Walk 2 Width (in)	N/A
	X Walk 1 Slope (%)	0.5		X Walk 2 Slope (%)	N/A
	X Walk 1 X Slope (%)	3.4		X Walk 2 X Slope (%)	N/A

N/A	Ramp inside XWalk1?	Yes	N/A	Ramp inside XWalk2?	N/A
	Road Slope (%)	N/A	N/A	Clear Space?	N/A
	Road X Slope (%)	N/A	N/A	Clear Space to XWalk (in)	N/A
N/A	Any Obstructions?	N/A	N/A	Storm Grate/Utility Hazard?	N/A
	Obstruction Type			Storm Grate/Utility Type	
		N/A			N/A
			Yes	Surface Condition? (G/P)	Good

**Remove & Replace Entire Ramp.**

Total Cost: \$ 1850.00
